<b>Standard Modification</b> Issue 2	Mod No. SM11906
		Page : <b>1</b> of 10
		Compiled : P Tunney
		Approved :

## TITLE : Stabilator Torque Tube Clamp

APPLICABILITY : **All Europa Variants**  
Mod Type : **New Build & Retro-fit**

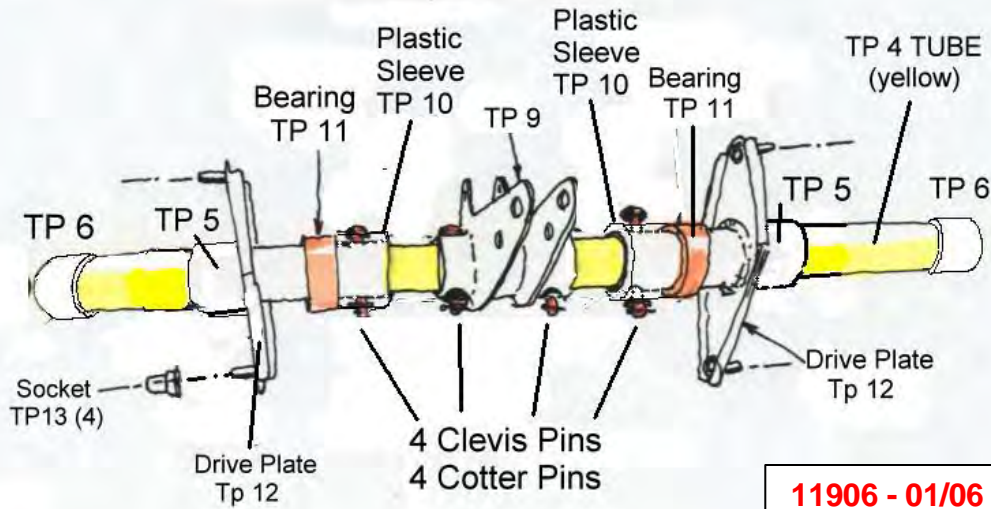
**11906 - 01/06**

The clamp has been developed to prevent wear and looseness occurring between the 4 clevis dowel pins that secure the TP12 drive plates and TP9 crank arm to the torque tube TP4. See attached sketch (11906-01/06).

- 1 – Minimal pin contact area (1/16") on the sleeves of TP9 and TP12.
- 2 – Poor initial installation from drilling through the sleeves of TP12 and plastic spacer sleeve TP10 that result in a larger hole or holes in TP12.

The clamp works by locking on all 3 major diameters of the components TP12, 9 and 4 and trapping shortened dowel pins in position. The clamps are machined to provide a 0.002" or 0.05mm interference fit on all 3 major diameters, and also to provide a neat fit between the ends of TP12 and TP9.
