LAA TYPE ACCEPTANCE DATA SHEET
TADS 189, A, B, C, D
AVID (VARIOUS)

Issue 2	Addition of MOD/189/008	Dated 05/02/21	JV
Revision A	Addition of Flaperon Mass balance Inspection point. Minor editorial changes.	Dated 24/03/21	MR

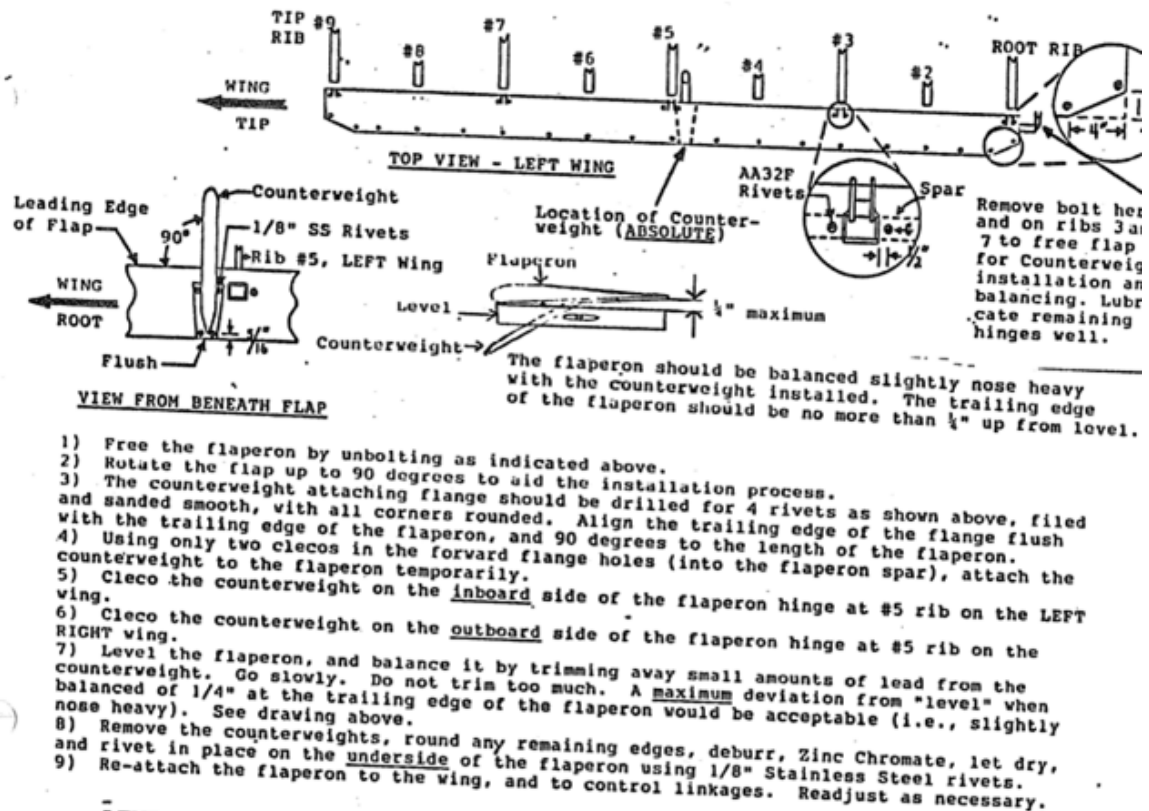
26. Flaperon Mass Balance – It has become apparent that due to the aging fleet of Avid types that understanding of the correct procedure for correctly balancing the flaperons may be less widespread, potentially leading to improperly balanced surfaces. Note that the flaperon mass balances for Avid types are

provided slightly overweight and require 'trimming' down to the correct weight to balance a particular aircraft's flaperon(s). An extract for the original guidance can be seen below.
