## EuroFOX Aircraft

### Checking of Elevator Trim Cable Assembly

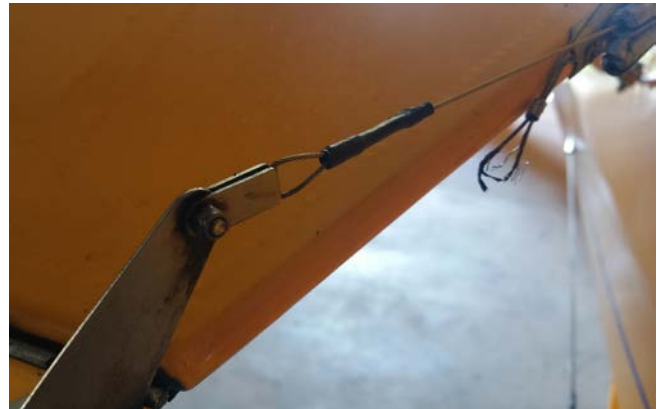
Fig. 1. This picture shows the detached bottom trim operating cable with the top cable still in place. Notice that the cable is forced around a sharp 90° angle: each operation requires the cable to go through an angular change causing fatigue in the individual strands.

An exacerbating factor in this failure was that the 'U' channel itself wasn't lubricated and was therefore very tight and stiff to rotate; this increased the amount of bending that the cable was forced through during each operational cycle.

This recent failure serves to remind us all of the need to include in an Aircraft's Tailored Maintenance Schedule a close visual inspection of all aircraft control cables and their connections.

To fully inspect a control cable may require removal of the cable from the airframe because the best way to check a cable for broken strands is to bend the cable into a loop between two hands and passing a cloth over the cable ... watch your fingers!

Though some wear along the length of a cable may be tolerated, especially if there's no blending between strands, cables must be replaced if it suffers a 'popped' core or any broken strands.

EuroFOX have issued a Service Bulletin (SB 04/2016) reminding owners of the need for regular checks in this cable connection: this Bulletin can be downloaded [HERE](#).

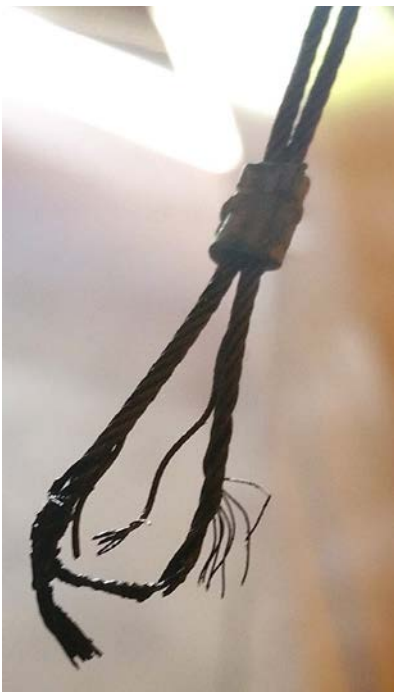
When the cable was detached from the 'U' channel by the engineer it was found that the cable had very nearly completely failed; had this cable failed in flight operational safety would have been compromised.

Fig. 2. This close up shows the extent of the damage found by the engineer when the cable was removed from the 'U' clamp. The point of bending is clear.
