Service Bulletin

Replacement of Undercarriage Guide Bracket Bolts

Applicability: All EuroFOX tail dragger aircraft operating under a UK LAA administered Permit to Fly.

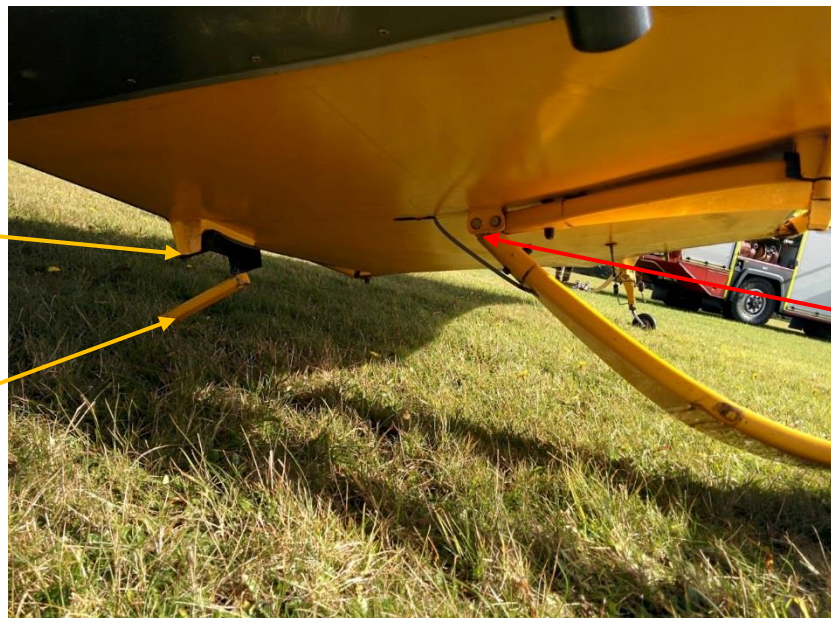
On a EuroFOX heavy use tail wheel glider tug aircraft with tundra tyres, the forward bolt failed on the undercarriage clamp bracket (containing 2 bolts M8 hex head 8.8 strength). The clamp bracket then swung away from the undercarriage leg just after take-off, and the leg itself being unrestrained, pivoted about its central fixing point in the middle and underside of the fuselage. A successful and very skilled landing was made on one leg and the tail wheel, with minimal damage.

On inspection, it became apparent that the bolt had failed in fatigue just under the bolt head. The fatigue crack had been present for a while, but is not easy to find during normal inspections. The earlier SB on this subject (SB2 2015) did not prevent this failure, therefore to minimise risk, it is required to change the assembly method and “life” of this bolt. The new fixing method will improve the load transfer within the assembly.

Broken bolt allowing the guide bracket to swing away and release the U/C leg

Clamp bracket

Pivot point on the tail dragger U/C leg. When released by the clamp bracket, the leg can swing freely away

View of the undercarriage clamp bracket assembly (tail wheel aircraft)

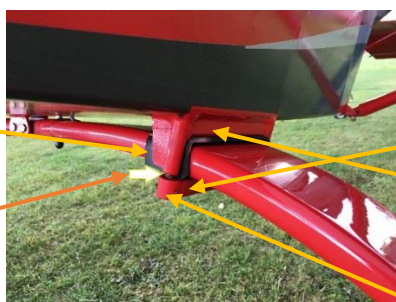
Rubber seating surround

Location of the new washer spacers x 3 pcs per bolt

P 05 Clamp bracket

Fuselage mounting bracket

2 x M8 bolts

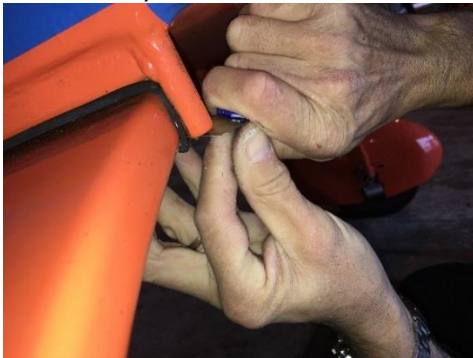
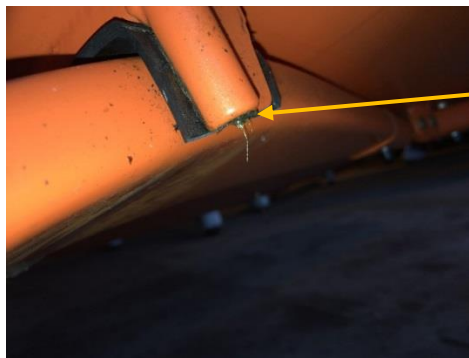
No rubber should obstruct this face

3. Trim the top fuselage rubber so that it is flush with bracket end as shown, so rubber does not foul new washer. Also ensure the top rubber is evenly and centrally positioned around the leg. Contact EuroFOX Aviation if you need new rubbers

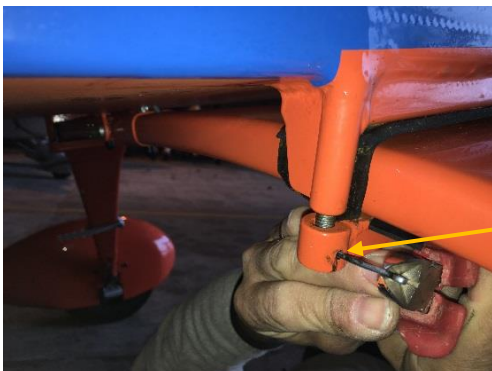
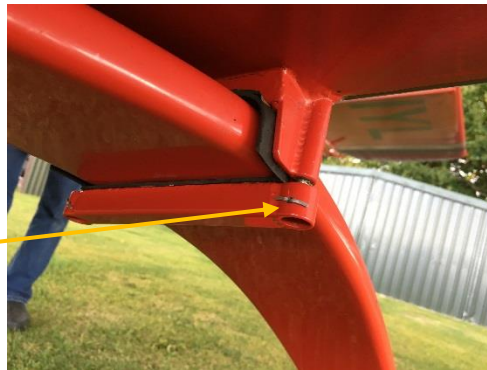
Inserting split pin shown left and right.
Note: photos shown without washers

- Determine where the M8 bolt split pin locating hole is in relation to the clamp bracket split pin locating hole and readjust the bolt torque to line them up. Then insert the securing split pin. Depending where these locating holes line up for the split pin, you will need to add a little more torque (max 24Nm), or slacken off the bolt to insert the split pin. **DO NOT overtighten the bolt more than 24Nm**. If this is needed to line up the split pin holes, slacken off the bolt torque in preference.

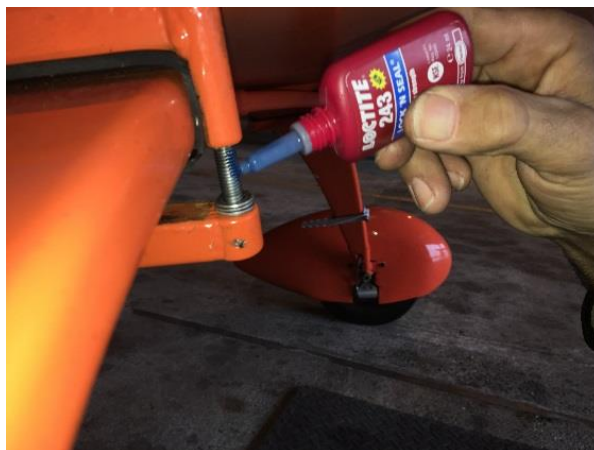
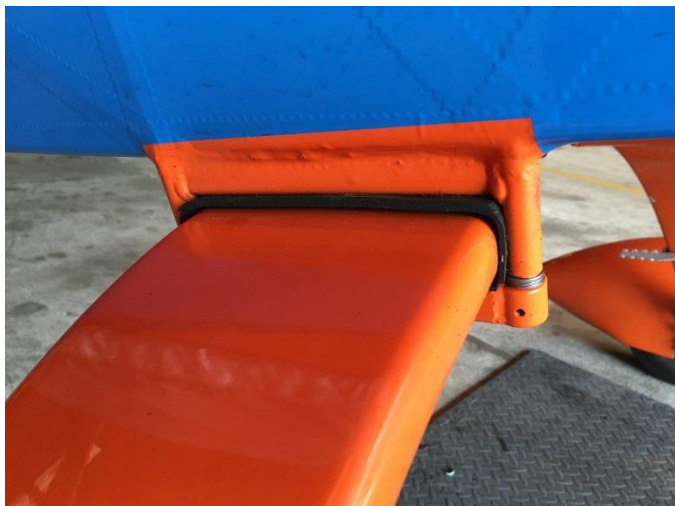
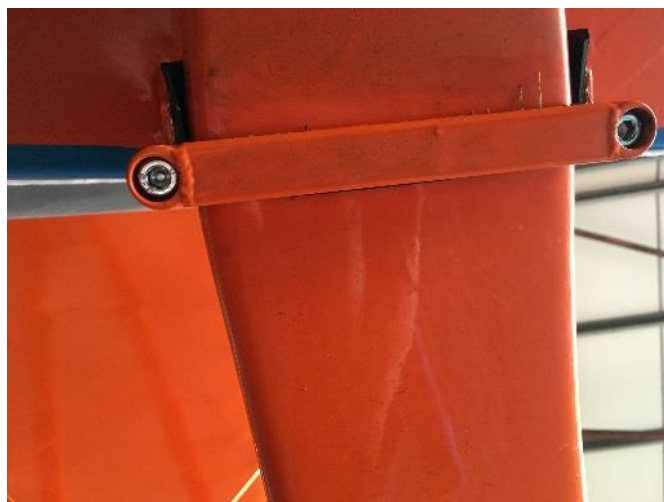
Finished assembly below with washers fitted (shown prior to split pin fitted)

- The washers should now be clamped firm between the U/C clamp bracket and the fuselage bracket with split pin inserted. The top and bottom rubber surround should not be loose or squashed out of place. If either of these happen, consult EuroFOX Aviation.
- If the split pins cannot be lined up without going over 24Nm or well under 20Nm, it is acceptable to use Locktite 222 on the threads instead of the split pin. Make sure the bolt threads and 8mm undercarriage bracket threads are clean and free of any grease.
