**LAA TYPE ACCEPTANCE DATA SHEET**  
**TADS 849**  
**LUSCOMBE 8A, 8A (MOD), 8E, 8 (MOD), 8F, 8F (MOD)**

Issue 2	AD summary relocated to Section 2	10/03/21	JP
Revision A	Update to contact details. Note on Cessna seat AD in section 2.5. Additional notes in section 3.4.	25/03/21	JV
Revision B	FAA SAIB on main gear leg corrosion added to section 3.3	03/06/21	JV

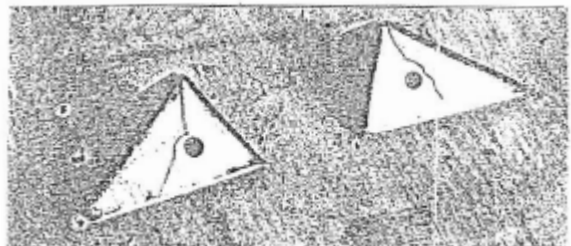
7. Cracked Forward Tailplane Fittings

Previously, there was a report of severely cracked forward LH and RH tailplane attachment fittings, part number 18128. These were discovered during the restoration of a Luscombe 8A aircraft, which has a total airframe time of 4642 hours. The cracks originated from the sharp edges of the relief holes at the corner of each sheet metal fitting and extend to the ¼" diameter hole for a forward tailplane attachment bolt. As can be seen in the picture, the cracks have branched around the bolt holes and

have progressed almost to the opposite edge of each fitting. These cracks would normally only be discovered with the aircraft disassembled. Inspectors should be aware of this potential problem and are requested that LAA Engineering is advised of any similar discoveries.

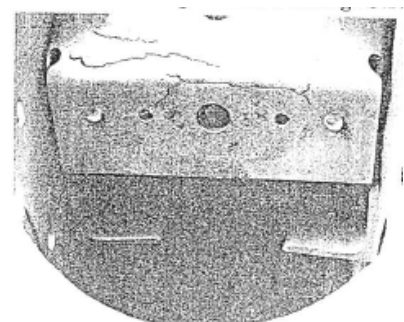
8. General Cracking of Rear Fuselage Structure

LAA Engineering did receive a report of quite 'extensive' cracking of parts of fuselage structure on a Luscombe. Frame 8, the rearmost bulkhead (fin post) was badly cracked as was the 'tail tray reinforcement' bracket shown in the picture opposite, Pt No 18110. Such defects would be very difficult to detect without

major disassembly but inspectors should ensure to inspect these structures as thoroughly as possible.
