**LAA TYPE ACCEPTANCE DATA SHEET**  
**TADS 854 - PIPER J3C-65, PIPER J3C-65 (MODIFIED),**  
**J3C-90, J3C-65 (LIPPERT REED), J3L-65**  
**TADS 859 – PIPER L4H, L4J**

Issue 1	Initial issue	Dated 25/04/14	JV
Revision A	Addition of Safety Spot articles	Dated 08/10/19	JH
Revision B	Additional variants added to header	Dated 11/12/19	JP
Revision C	Deletion of AD 72.01.01 (not applicable to type), amendment of AD reference (99.01.05 is now 2015-08-04)	Dated 03/02/21	JV
Revision D	Inclusion of L4 variants in applicability	Dated 26/08/21	FD

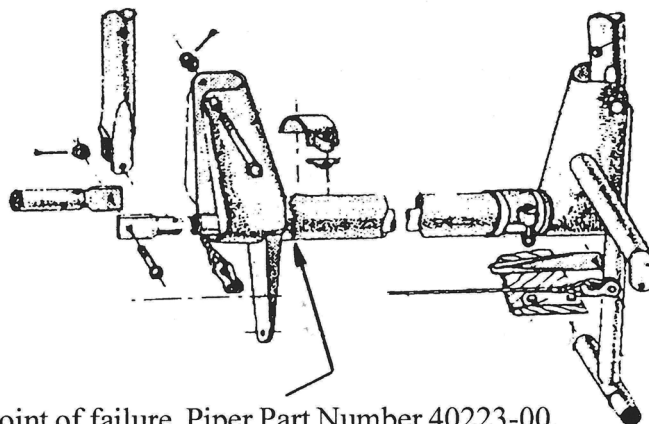
Point of failure, Piper Part Number 40223-00.

- In October 1995 an LAA Piper J3 aircraft was preparing for flight when, during pre-take off checks, the pilot found the controls had gone sloppy. It was later discovered that the torque tube shaft between front and rear control columns had sheared at a point adjacent to the weld connecting shaft to rear column. Front column had elevator control but no aileron. Rear column had no elevator control and only sloppy ailerons. The aircraft was built in 1946 and had flown around 1600 hours. It is not known what external causal factors might have existed. An inspection of this area for cracks is recommended. See diagram below.

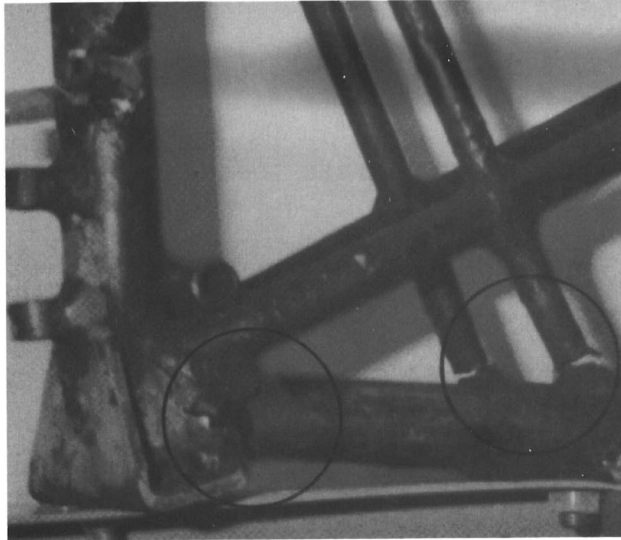
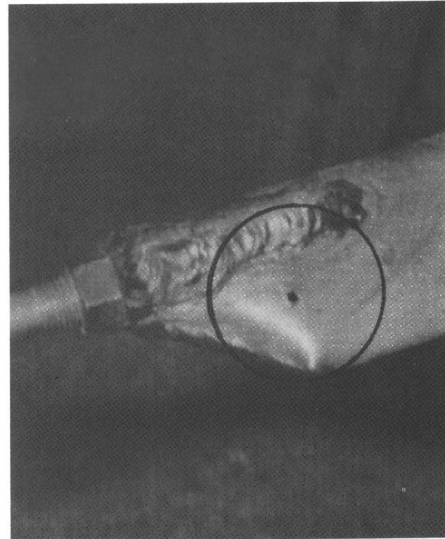
- Much of the LAA Piper fleet was built in the 40's and 50's and being largely constructed from steel tube, corrosion is a problem for owners and inspectors to be continuously alert for.

THESE PHOTOS SHOW ADVANCED CORROSION TO A VAGABOND FUSELAGE TAIL END, CORRODED & CRACKED RIGHT THROUGH IN THREE PLACES & THE SORT OF CORROSION AD 99.01.05 IS INTENDED TO DISCOVER (J3 WING STRUT).
