LAA/AWA/19/20(2)
28th October 2019

Auster 6A (Series) and Beagle Terrier (Series)

Inspection of Flap Auto-Trim Interconnect Cables

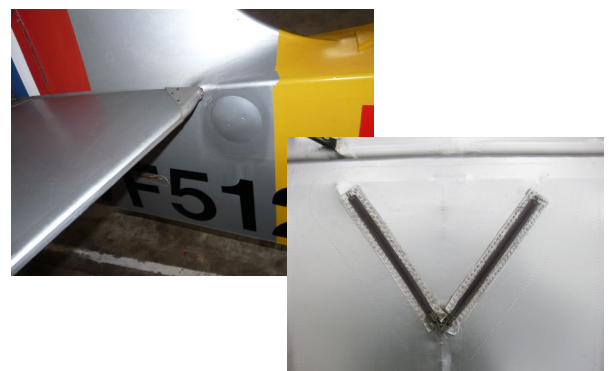
Fig 2. The internal structure of the fuselage on many tail-draggers is a difficult area to access and therefore to inspect fully. This latest AIL introduces a repetitive inspection of the trim cables so, though not mandated by the AIL, to improve access to the cables it is recommended that Auster owners fit an inspection pop-panel or a more weather-proof aircraft quality zipper in the side of the fuselage, as shown above.

Because of this recent incident, LAA Engineering has issued an Airworthiness Information Leaflet (AIL) requiring operators of Auster and Beagle Terrier aircraft to inspect the flap-trim interconnect cables each 100 hrs. or every three years coincident with the Permit renewal inspection.
