Vans Aircraft

Rear Spar Web – Inspection for Cracking

Service Bulletin 16-03-28

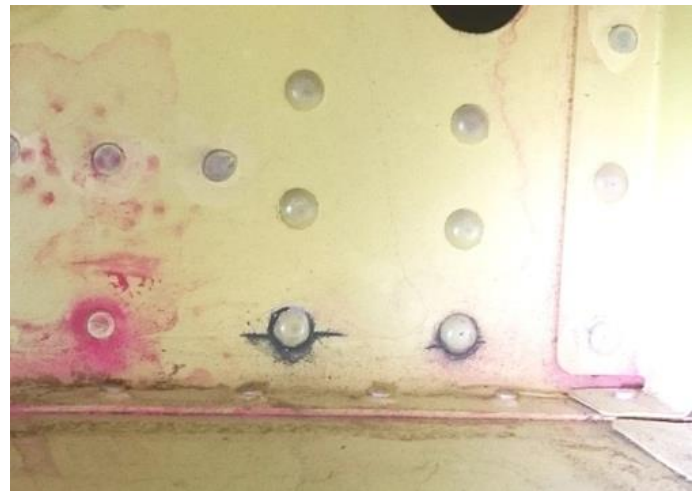
Fig. 1. Cracking of wing aft. spar web at the inboard aileron hinge. This picture, taken from the Service Bulletin, shows a view taken from inside the wing (looking aft.). (Courtesy of Vans Aircraft).

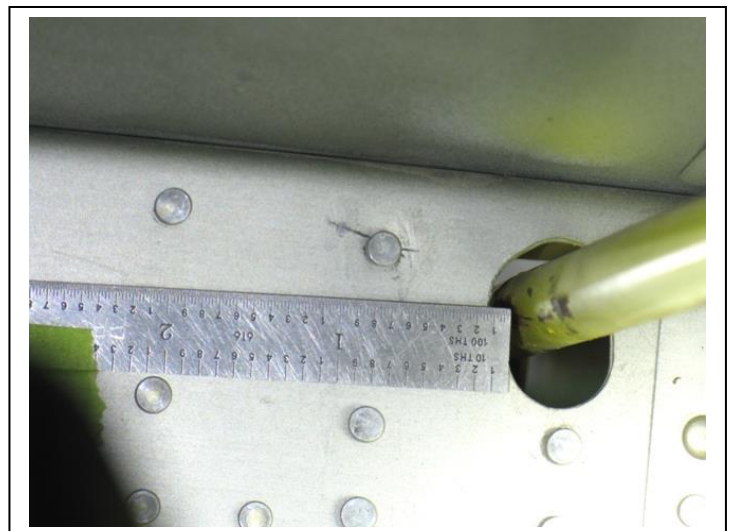
At the time of writing this ALERT three LAA RV owning members have let us know the results of inspections they have made. Two of the aircraft are clear of cracks and one, a fairly high time aircraft often used for aerobatics, has cracks emanating from both the top and bottom rivet connections (see fig. 2).

Fig. 2. This picture shows a well-developed crack from the top of the bracket; Vans Aircraft suggest that, should a crack develop it will be slow to propagate and, based on examples found thus far, the issue is less related to hours flown than the aircraft's usage profile. (Courtesy of Vans Aircraft)

Clearly, cracking at this point on the airframe must be taken seriously and LAA engineering suggest that an inspection be made at the earliest opportunity; though we don't feel that an aircraft needs to be grounded until the inspection is completed (as has been suggested in the SB).

Whilst we have no reason to suggest that the Vans repair scheme isn't appropriate, LAA members are reminded that any repair scheme affecting an LAA aircraft must be approved by LAA Engineering before a repaired aircraft is cleared for further flight.
