MOD/162B/004 issue 1

MANDATORY MODIFICATION MOD/162B/004

ZENAIR CH 601 XL

Applicable to aircraft operated in the UK under LAA approval

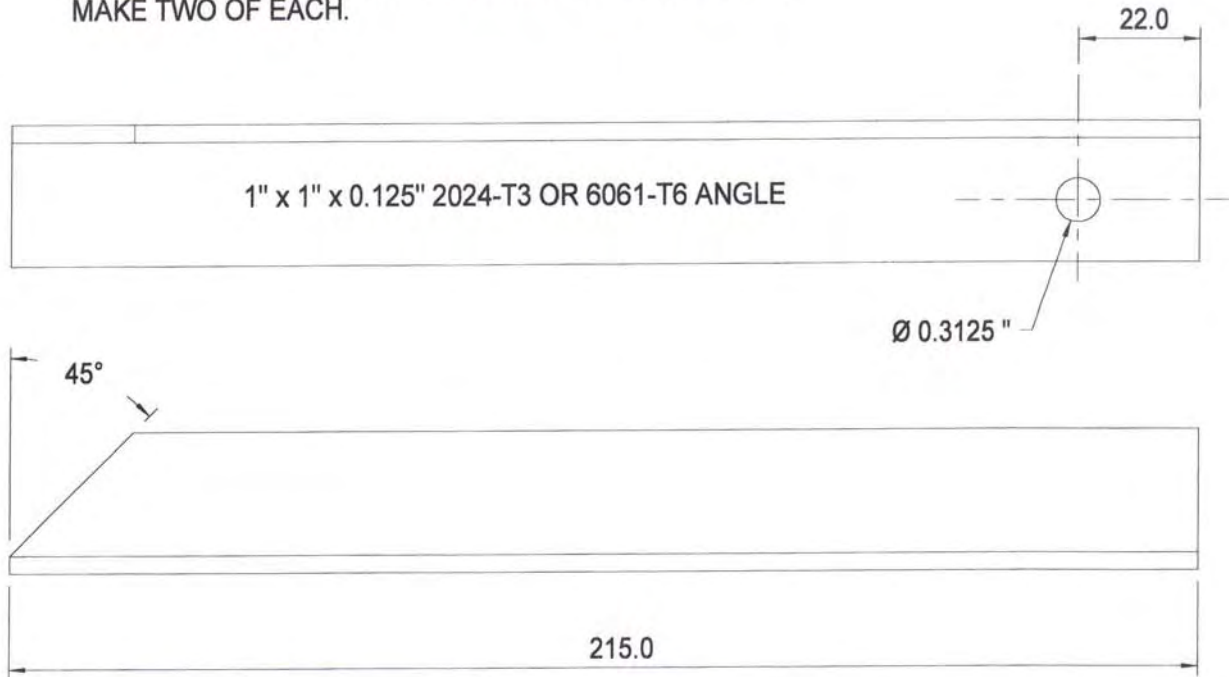
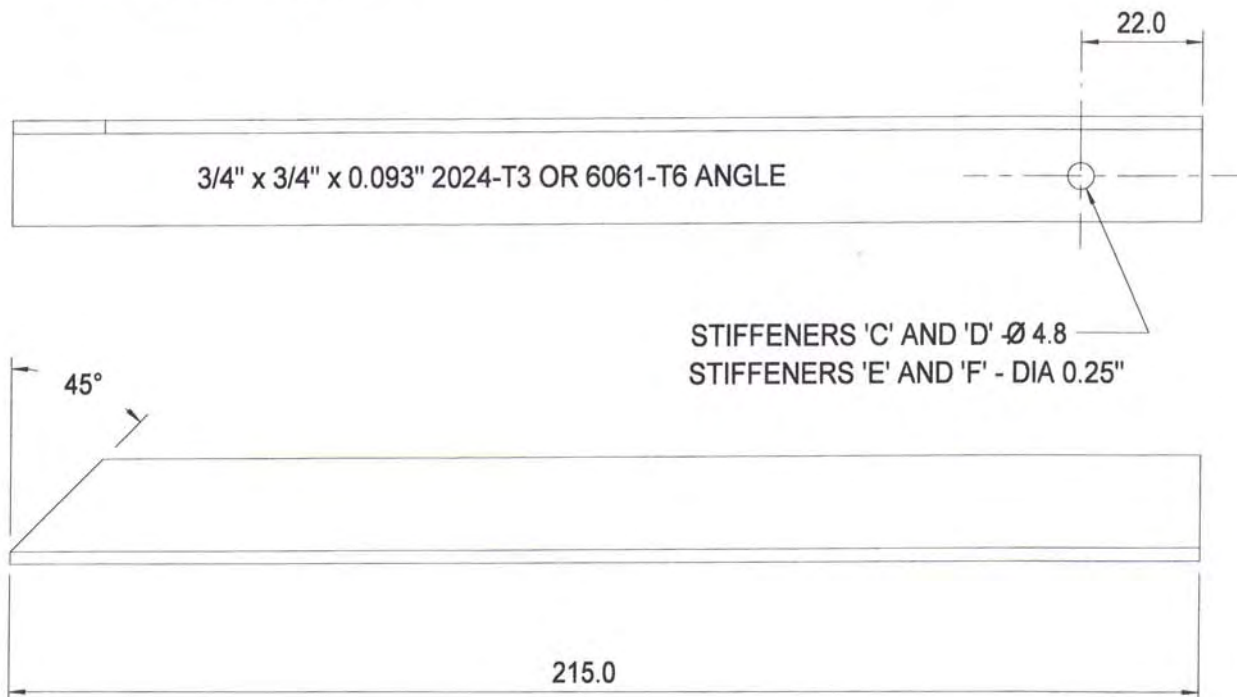
FIGURE 2. ANGLE STIFFENERS FOR ZENAIR CH 601XL CENTRE SECTION SPAR

STIFFENER 'A' SHOWN, STIFFENER 'B' OPPOSITE HAND.
MAKE TWO OF EACH.

STIFFENER 'C' SHOWN, STIFFENER 'D' OPPOSITE HAND.
MAKE TWO OF EACH - (NOTE: MAKE ONLY ONE EACH FOR TWO STICK VERSION.)

STIFFENER 'E' SHOWN (BUT WITH 0.25" DIA HOLE), STIFFENER 'F' OPPOSITE HAND.
MAKE TWO OF EACH

9. The additional stiffening angles are manufactured per figure 2. Note that the stiffeners are handed. Drill bottom bolt holes only in each angle. Upper bolt holes in angles must be very carefully drilled pilot sized on assembly to match existing upper holes in structure, using temporary drill bushes to centre the pilot drill on the existing holes in the structure. ¼", 3/16" and 5/16" outside diameter drill bushes will be required for the inboard, mid-span and outboard pairs of stiffeners respectively.

10. Once satisfied with the pilot hole positions, open up bolt holes in stiffeners to final size on the bench. Take great care as all bolt holes must be round and of the correct size. Oversize, ovalled or figure-eight holes are not acceptable either in the stiffening angles or the structure. **DO NOT ATTEMPT TO DRILL STIFFENERS FINAL SIZE THROUGH THE BOLT HOLES IN THE STRUCTURE AS THIS MAY DAMAGE THE HOLES IN THE STRUCTURE. OUT OF ROUND OR OVERSIZED HOLES IN THE STRUCTURE MAY MEAN REPLACING THE WHOLE CARRY THROUGH SPAR.**

11. Trial fit the stiffening angles to the front and rear faces of the carry through spar, in accordance with Figure 1. Drill rivet holes in stiffeners to dimensions on Figure 3, then transfer drill to structure. If rivet holes are already existing in structure at outboard stiffener location, transfer drill rivet holes from holes in structure to stiffeners.

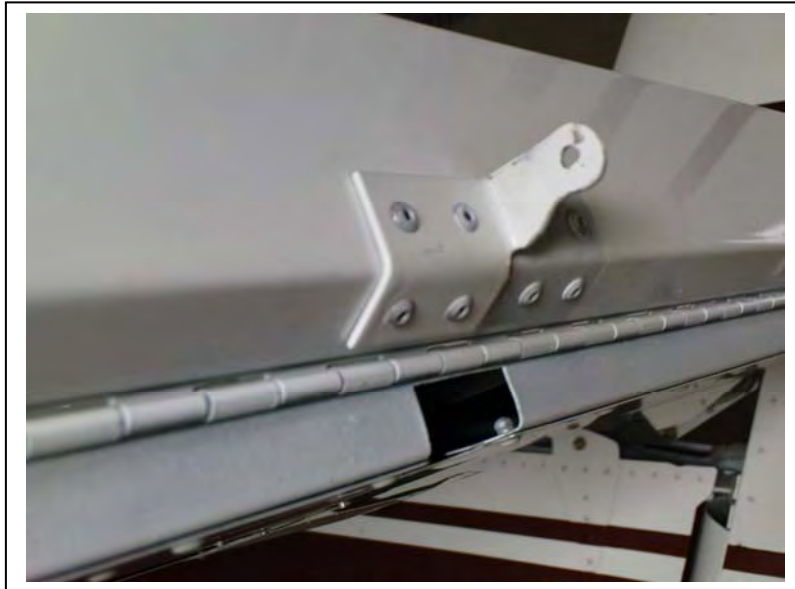
Fig. 5. The re-positioned Elevator Trim Horn.

Trim Tab Horn rotated through 180°, new holes drilled and refitted. Note that the redundant holes must be filled with rivets.

2. Drill out four 1/8" rivets attaching elevator trim tab horn to elevator tab, remove horn from tab. Fill redundant holes in tab with Avex A4 rivets.
3. Turn horn through 180 degrees and re-fit so that horn projects below tab, ensure horn is relocated at same spanwise position on tab as previously ie aligned with slot in elevator for tab pushrod. See figure 5. When satisfied with location, drill tab for 1/8" rivets and rivet horn to tab with A4 rivets, using JC5A, Duralac or similar corrosive-preventative assembly compound.

6. The trim tab horn may need to be relieved slightly around the front edge for clearance with the rear plastic fork on the pushrod, see figure 5. Ensure at least 8mm edge distance preserved from centre of 1/8" diameter hole to front edge of horn.
