LAA/AWA/18/05
25th July 2018

Sensenich 2 Bladed Ground Adjustable Propeller

Inspection of Propeller Hub

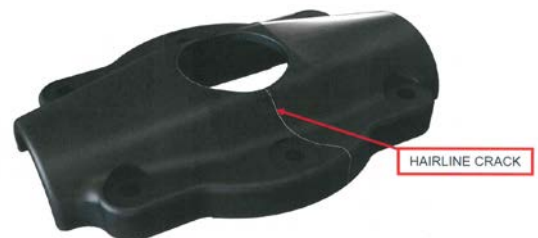
Sensenich Propeller Co., Inc., the propeller manufacturer, has received reports of cracked front hubs on several tractor and pusher installations with Jabiru (direct drive) engines. In June 2018 they received a report of a failure on a tractor Rotax installation (damped gearbox). To date there have been no known in-flight blade separations, though a crack in the primary propeller attachment could lead to such an event.

Fig 2. This picture shows the front half of the earlier model 2A0 propeller hub (Revision 'D' and earlier). Cracks appear to be originating from the pitch setting marks impressed into the hub; it is essential to remove the hub to inspect as hairline cracks may be difficult to spot.

The LAA has recently published an Airworthiness Information Leaflet (AIL) (MOD/SEN/001 issue 1) which mandates a manufacturer's Service Bulletin (Sensenich SB2016-06B). The SB requires that the propeller assembly is disassembled so that a thorough visual inspection of the propeller hub can be completed.

The manufacturer requires that this inspection be carried out before further flight and then each fifty hours (or annually, whichever comes first).
