CHECK & CHECK AGAIN

How a carbon monoxide indicator in your cockpit may save your life, and why you must inspect fuel filters and undercarriage components

SportCruiser – exhaust problems

The heavy landing

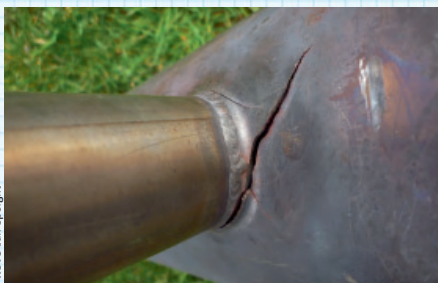
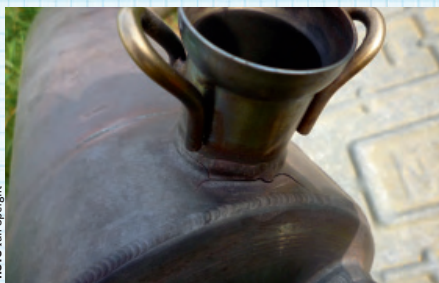
These are pictures of Ian's exhaust after it was removed and disassembled. The exhaust is badly cracked in two separate areas, which is worrying. On the previous flight, the CO monitor was clear which suggests that this failure occurred fairly rapidly once it got started. The LAA is conducting a survey among SportCruiser owners about their experiences with cracking.

“As per your advice, the box is being expertly welded and will be refitted awaiting the proposed mod. However, I intend to block off the scat pipe to the cabin just in case.”

Take a look at the excellent picture taken by Ian of the crack around the weld. What worried me more than almost anything is the fact that carbon monoxide (CO) was present in the cockpit even though the cabin heater was off. Well done to the pair of them for fitting a CO monitor, which are very sensitive devices and will measure even small concentrations of this dangerous gas.

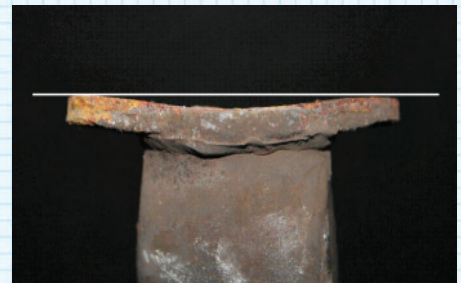
This picture shows the exhaust flange recovered from the wreckage of the Nord NC854S that crashed, killing both occupants. CO poisoning was implicated and the poor seal afforded by this flange may have contributed. It is possible that the distortion was exacerbated by the crash itself, though, and the poor seal may not have been that obvious during the pre-flight inspection.

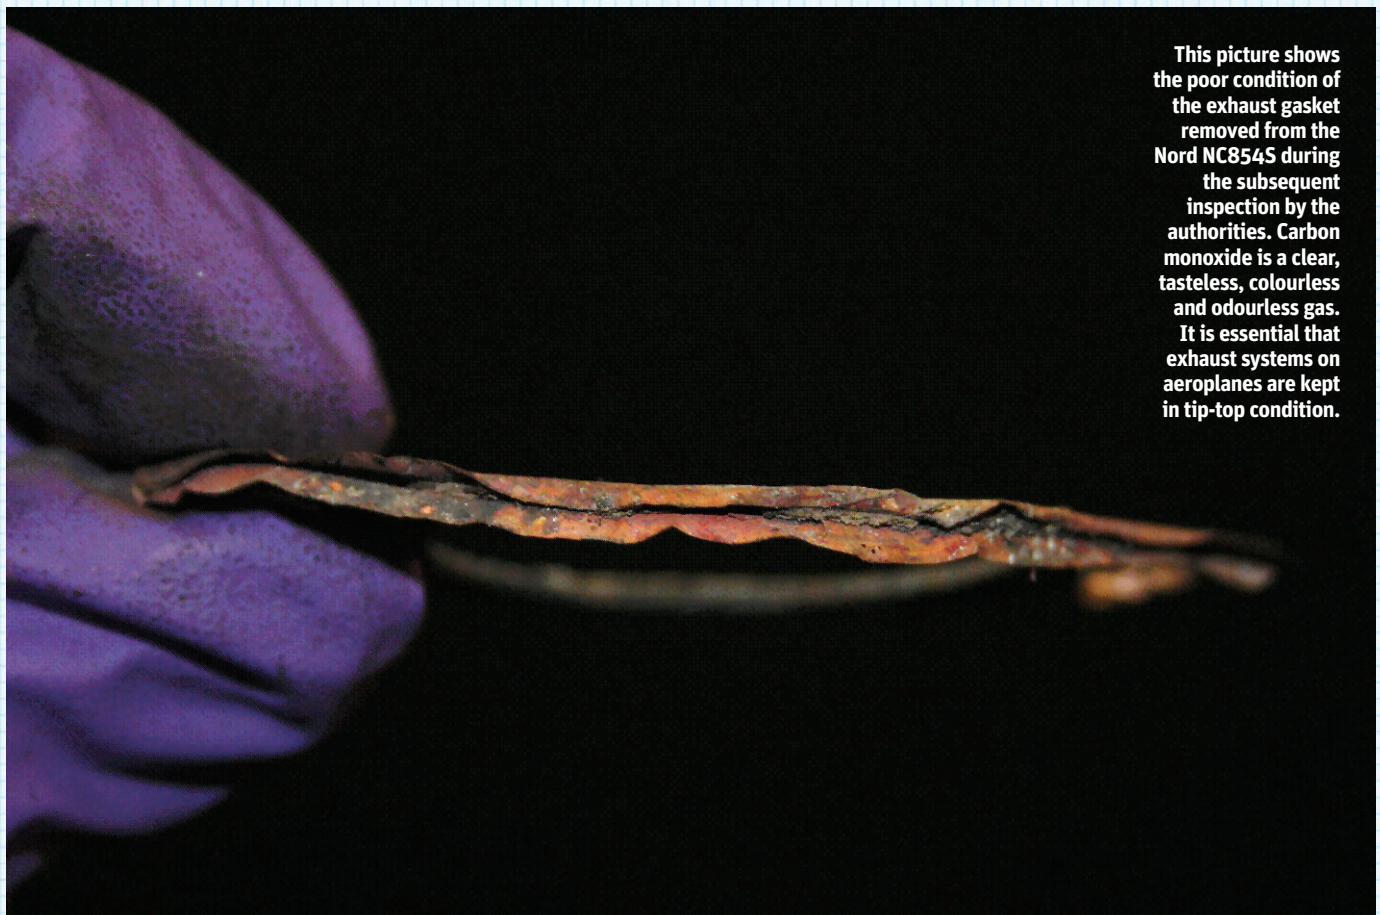
This picture shows the poor condition of the exhaust gasket removed from the Nord NC854S during the subsequent inspection by the authorities. Carbon monoxide is a clear, tasteless, colourless and odourless gas. It is essential that exhaust systems on aeroplanes are kept in tip-top condition.

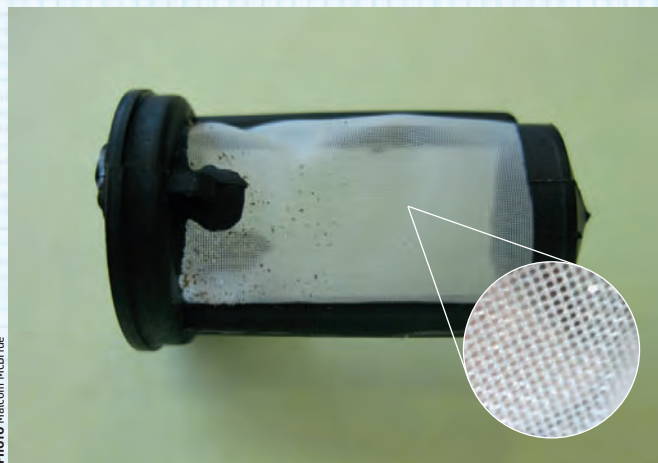
In this example of a very common filter element note that, although the hole size is roughly the same, the area available for holes is far greater. Look at the construction of the mesh in the blow-up. You can work out for yourself that this second type of construction would be able to absorb far more debris than the first type, even though the filter-ability would be approximately equal.

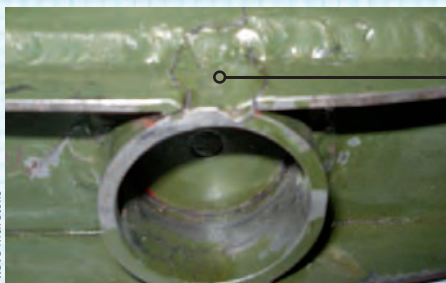
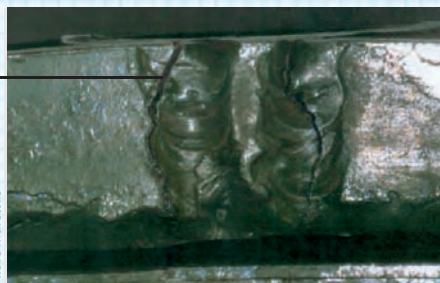
Nick sent me these pictures showing cracking damage to a Culver Cadet undercarriage. To see this crack you would probably need a torch and a mirror without complete disassembly. These 'close inspections' need to be done during a heavy landing inspection and at the annual check. Often the deeper you get into an inspection the more is found.

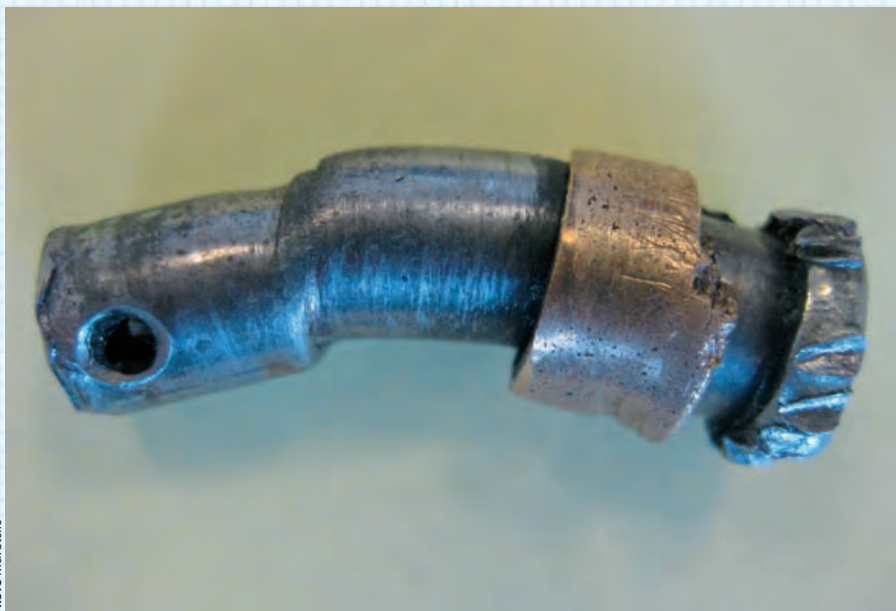
Check out this photograph of a failed, or very nearly failed, main undercarriage hinge sent to me by owner Justin Kennedy. Like others, he found landing challenging in the early days and did a really heavy landing while learning the best technique. The aircraft was thoroughly inspected and there was nothing amiss. After 600 or so undercarriage cycles all still appeared in order but he noticed that the tyre was scrubbing on one side slightly. A closer look revealed why. This is about the best example of plastic deformation in shear that I've ever seen outside of a lab.

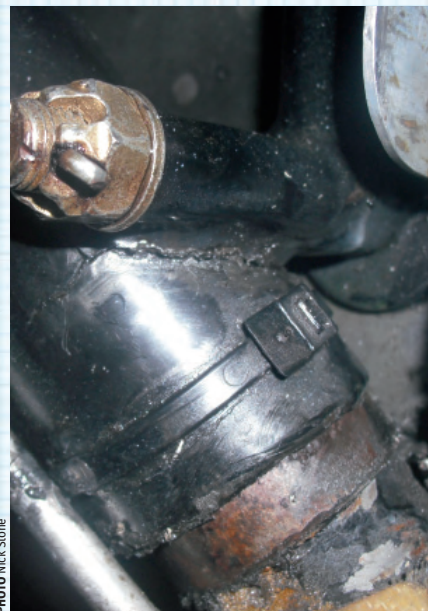
This crack was found in an RV6 main undercarriage leg. RV6s have a bit of a reputation for cracks at the top of the legs. As you can see, this one would be difficult to find without removing the bottom engine cowling. This aircraft had about 280 hours on the clock.
