LAA/AWA/21/08
1st November 2021

Europa Aircraft – All Variants

Door Losses

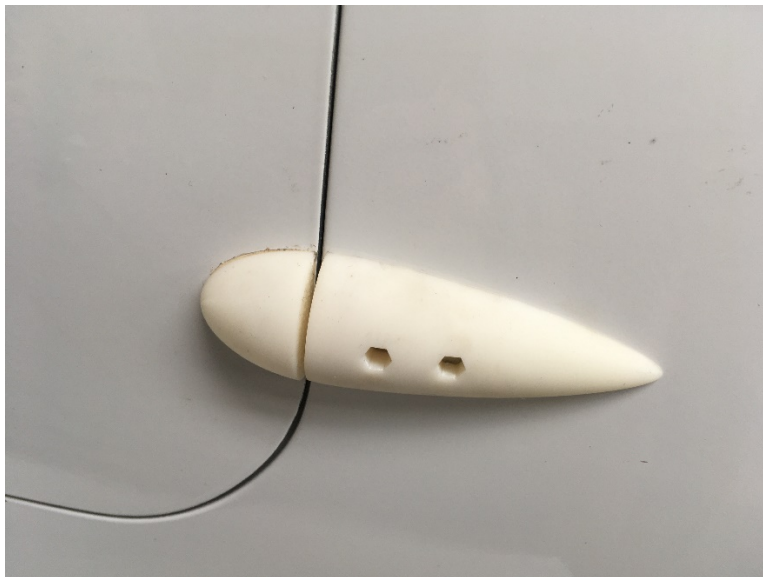
An aerodynamically shaped stop (see photo), secured to the fuselage outside surface immediately aft of the door where the rear shoot-bolt would go should the door not be closed properly, has been shown to be effective in alerting the occupant that the door is not properly closed and its installation is described in LAA [Standard Mod SM15833](#).

It is considered most likely that the door losses are due to mis-latching the door before take-off, therefore a means to prevent further occurrences has been designed and is the subject of an LAA Standard Modification. Due to the potential for catastrophic consequences should a Europa suffer a door loss in future, LAA Airworthiness Information Leaflet MOD/247/012 has been issued making this Standard Mod mandatory, to be accomplished before the next 5 flying hours or the next Permit to Fly revalidation, whichever is the sooner.
