## Jodel Aircraft Landing Lamp Cover Inspection

The Light Aircraft Association has just issued an Airworthiness Information Leaflet (AIL) (LAA/MOD/235/002 issue 1) requiring checks to Landing Lamp Covers on all Jodel D150 Mascaret Aircraft, this AIL can be downloaded [HERE](#).

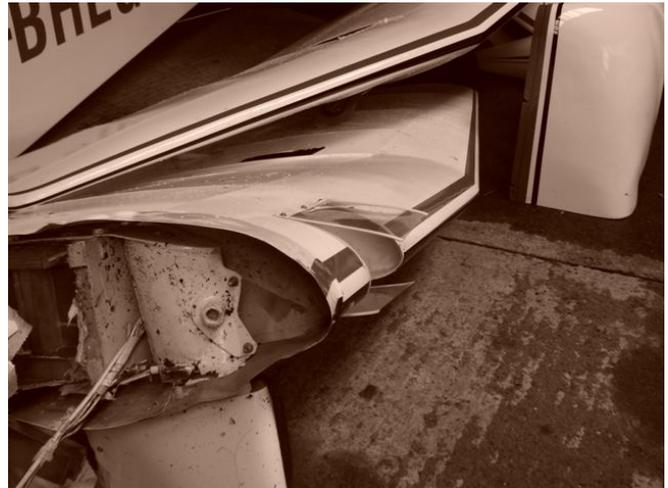
In the incident, a standard Plexiglas landing lamp cover was replaced with a locally manufactured Polycarbonate cover; this cover failed along its leading edge during a take-off shortly after fitting (see Fig. 1.).

The reason for this failure is not fully understood although, because the part had not been heat-formed, it didn't retain its shape around the leading edge after it failed.

Fig. 1. The landing lamp cover fitted to this Jodel D150 Mascaret returned to its unformed shape, effectively a flat sheet, after failing in flight; this failure led to control difficulties for the pilot.

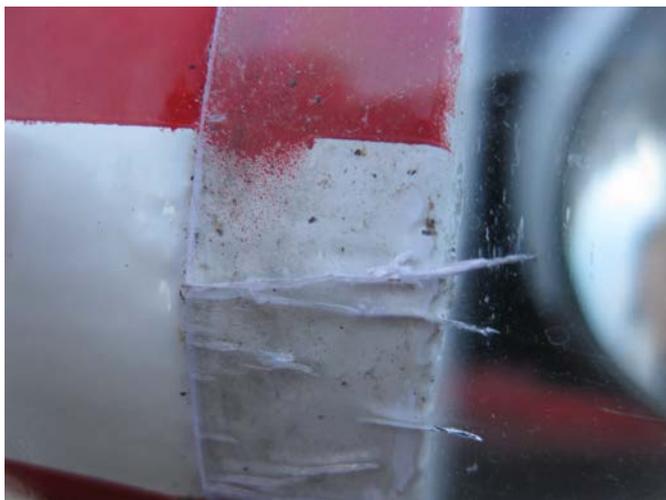
Fig 2. This picture shows an example of stress induced crazing which can lead to a local crack and subsequent failure of the part; this leading edge crazing has been caused because the part hasn't been heat formed. Jodel owners should be mindful that, should this part eventually fail, its failure might generate unforeseen flight safety problems for the pilot.

Polycarbonate sheet of an identical thickness and equivalent transmissivity (to light) is accepted as an alternative to acrylic sheet (Plexiglas) for use in transparent components (AC 23-27). However, differences in the material will affect the manufacturing techniques employed (when cutting, drilling or forming) and the subsequent maintenance of the part (for example, the choice of cleaners or polishing techniques).
