All Escapade & Easy Raider Owners

25th February 2010

Escapade airworthiness alert

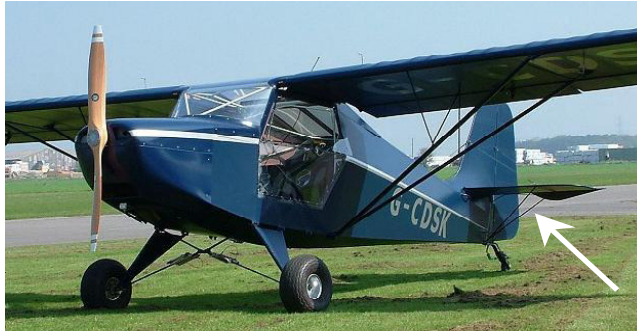
The day before yesterday (23rd February) it was discovered that one of the struts supporting the horizontal stabiliser on a low hours Escapade had fractured. See figure 1. The fracture had occurred at the flattened end of the strut where it bolts onto the tailplane spar. See figures 2 and 3. The fracture surface is indicative of a fatigue failure, rather than an overload failure, and has also corroded. See figure 4. The strut ends that had not failed had defined tooling marks, even on the outside of the bend. This may have acted as a fatigue crack initiator on the failed end. See figure 5. The Easy Raider has the same part fitted.

Figure 1: Escapade showing location of affected strut.

To inspect the strut the underside of the horizontal stabiliser needs to be accessible, clean and well illuminated. Consider lifting the tail of aircraft in tail-wheel configuration.

Look for any cracking of the paint or corrosion showing through the paint. Robustly pull the strut (by pushing the horizontal stabiliser upwards) and twist the strut to ‘open’, and help identify, any crack. If there are any signs of distress the strut should be removed from the aircraft and the end cleaned (e.g. shot blasted) to allow further investigation (e.g. dye penetrant inspection).

- Do not fly with a cracked strut.
- Add careful inspection of the strut ends to your daily inspection.
- If a strut is removed and found to be OK, protect with a clear lacquer before returning to the aircraft.
- Refit struts in accordance with the UK Build Manual.
- Disturbed primary structure requires a second inspection by a suitably qualified person before further flight.

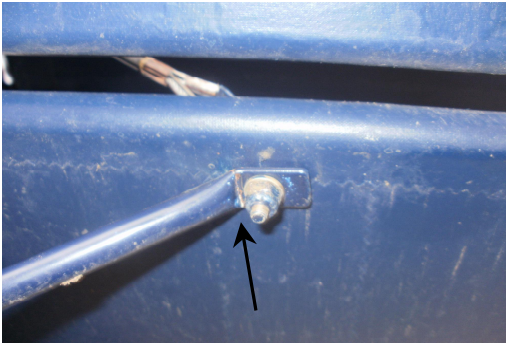
Figure 2: View from underneath horizontal stabiliser showing crack at flattened end of strut.

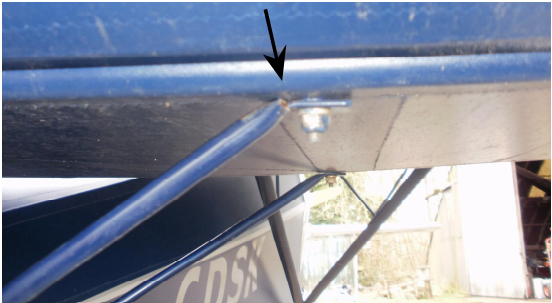
Figure 3: View from rear of horizontal stabiliser (elevator raised) showing crack at flattened end of strut.

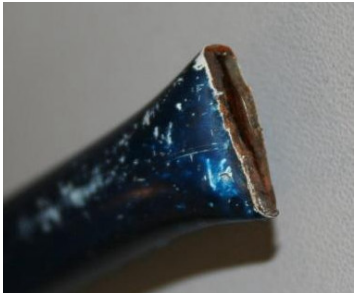
Figure 4: Fracture surface (strut removed from aircraft)

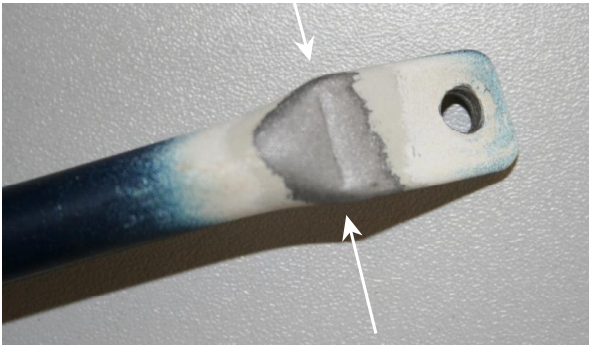
Figure 5: Tooling marks on outside of bend (undamaged strut – shot blasted)

- Whether there is any cracking of your aircraft’s strut ends or not.
- Whether there are tooling marks on your aircraft’s strut ends or not. A strut may have to be removed to assess this satisfactorily.
