LAA/AWA/15/02 rev1.
23rd March 2015

British Gliding Association Concerns about Kaurit Glue

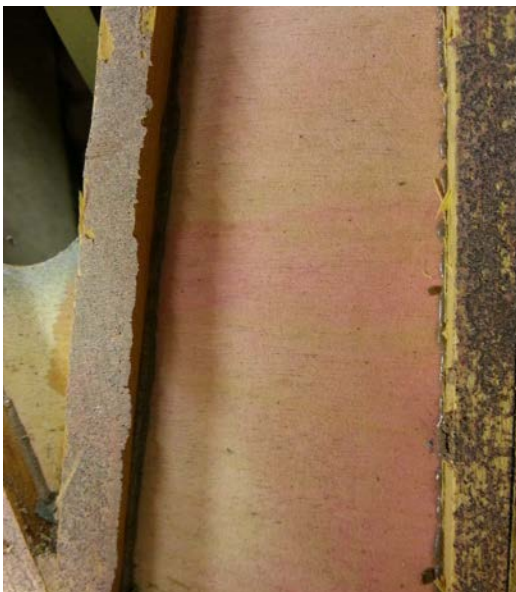
Fig. 2 A closer look at the failed glue joint reveals that the actual failure appears to have occurred along the wood-activator joint (not shown); the resinous joint appears still to be functional. (Courtesy of BGA).

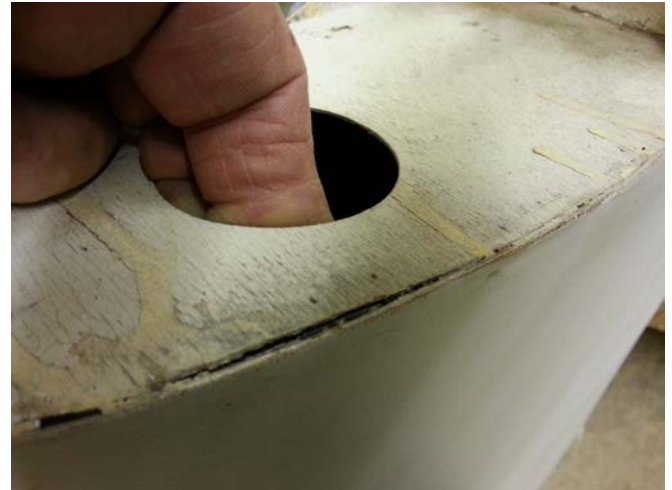
Fig. 1 This is a picture showing an inverted K8 fin; note that a very light pressure applied to the bottom rib reveals the failed glue joint. A complete failure of this joint could lead to the loss of the fin and compromise elevator control. (Picture courtesy of BGA)

In February 2015 the British Gliding Association's (BGA) Technical Committee (TC) decided, after the discovery of a serious glue failure in a Schleicher K8's fin attachment during the required five yearly glue inspection, to require an additional full and detailed inspection of all glued wood joints in gliders at (or before) the next annual inspection, regardless of when the last scheduled inspection was completed. The BGA TC also decided to increase the frequency of these specific inspections from five to three years.
