LAA/AWA/16/02
28th April 2016

Dyn Aero MCR-01 – All Marks

Tailplane Attachment – Report of Attachment failure

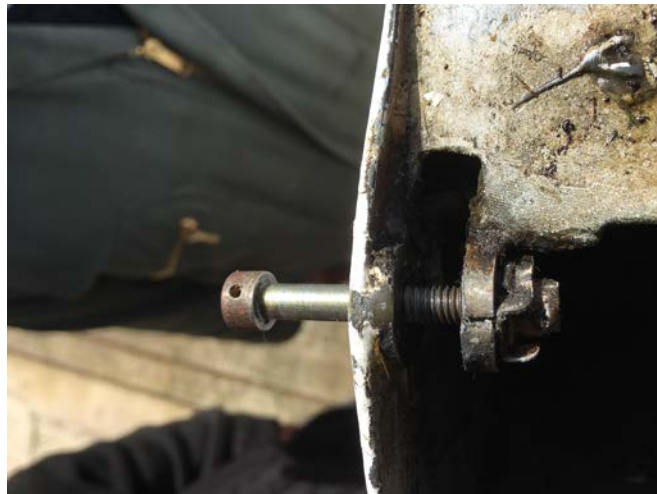
LAA Engineering has received a report about the accidental discovery of a failed tailplane attachment lug (See Photo Right). At this early stage in the investigation we are not sure why this lug has failed but, especially bearing in mind the critical nature of this primary fitting, we felt it important to alert all MCR-01 owners in our fleet of this occurrence; to accomplish this the LAA has written to each aircraft owner directly, suggesting that they don't fly their aircraft until visual checks have been made and they know their attachment fittings are sound. This Airworthiness Alert, in addition to providing general safety information to the wider membership, also provides a means of access to copies of previously published but still relevant Information leaflets and an associated Mandatory Permit Directive: this information is listed below.

Fig. 1. This picture shows clearly that one lug in this tailplane attachment bracket has failed. The discovery of this failure came about by accident when an observant LAA Inspector noticed excessive play in the tailplane of the aircraft as it was being moved in its hangar.

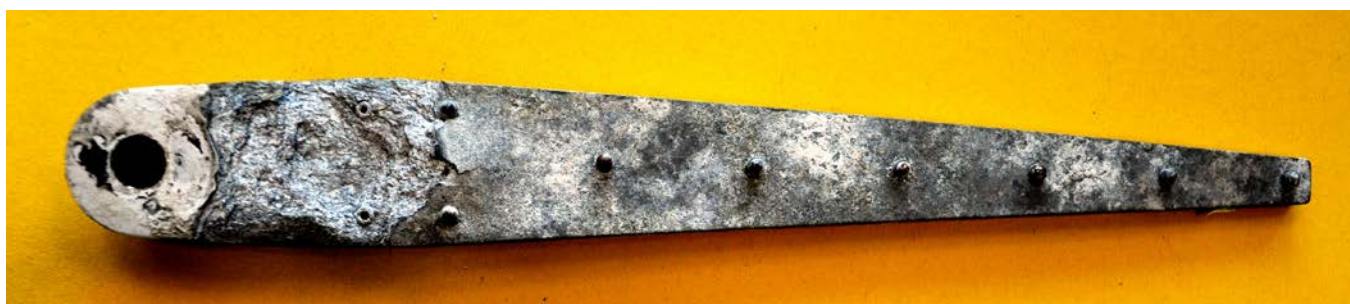
Fig. 2. In 2011, an MCR-01 forward wing attachment fitting fell off the wing whilst de-rigging the aircraft in preparation for re-painting; the corrosion present throughout the attachment surfaces and the failed attachment rivets are clear in the picture above. LAA Engineering produced an Airworthiness Information Leaflet (AIL) requiring immediate and then subsequent (3 yearly) de-rigs so that wing attachments could be checked: this AIL was mandated by a CAA MPD in April 2011.

Corrosion is a serious issue on all aircraft but this is especially so on types that have been built especially light for maximum performance: the MCR-01 series of aircraft fall into this category. Corrosion issues on this type have featured in a number of Safety Spot articles over the years, notably April and June 2010 and June 2011: All Safety Spots can be downloaded [HERE](#). LAA/MOD/301/021 (Mainplane attachment Bracket Inspection) can be downloaded [HERE](#). LAA/MOD/301/022 (Inspection of Aluminium Fittings) can be downloaded [HERE](#). CAA MPD 2011-002-E can be downloaded [HERE](#).
