SAFETY SPOT

Malcolm McBride
Airworthiness Engineer

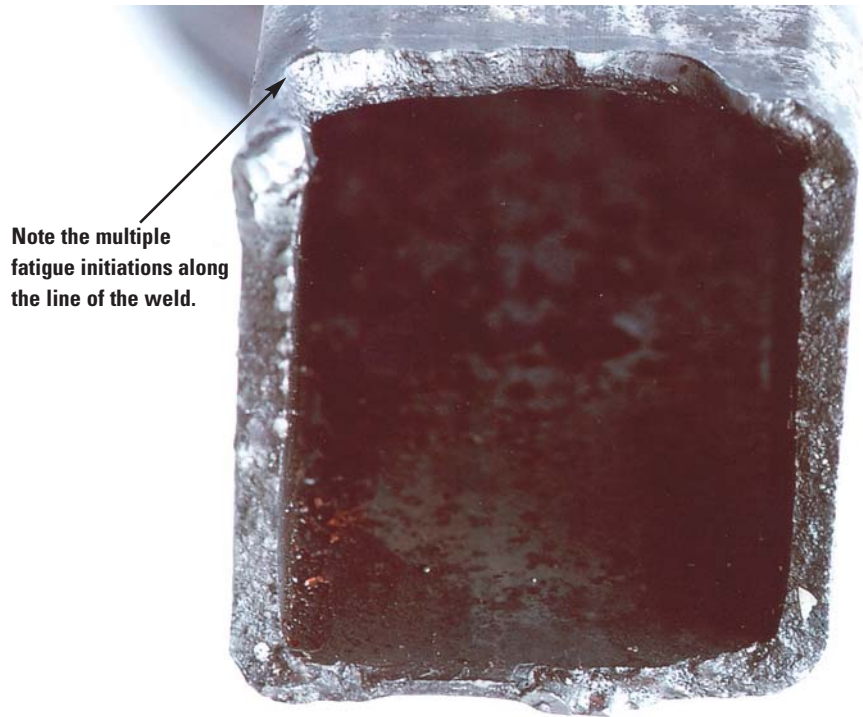
Pulsar Nose Undercarriage failure

Note the multiple fatigue initiations along the line of the weld.

of the failed component which I am happy to share, note the multiple fatigue initiations. This component had been about to fail for some time and an earlier *Spot* may have prevented an expensive (unexpected) propeller change and a trailer ride home.

We have just issued an Airworthiness Information Leaflet (AIL) requiring an inspection of the nose undercarriage drag brace on Pulsar aircraft. This is in response to an accident at Popham last year when the nose undercarriage failed during the landing; Popham's runway is pretty smooth, the pilot had made a good landing, so the only real damage was the loss of the propeller and the failed undercarriage component. After an AAIB investigation, it was shown that the undercarriage drag brace support had failed at the point that it was welded to the engine mount frame. I have discussed before how a material can change in the area of a weld; local, unresolved internal stresses coupled with a change in temper can initiate fatigue foci. The AAIB kindly supplied some photographs

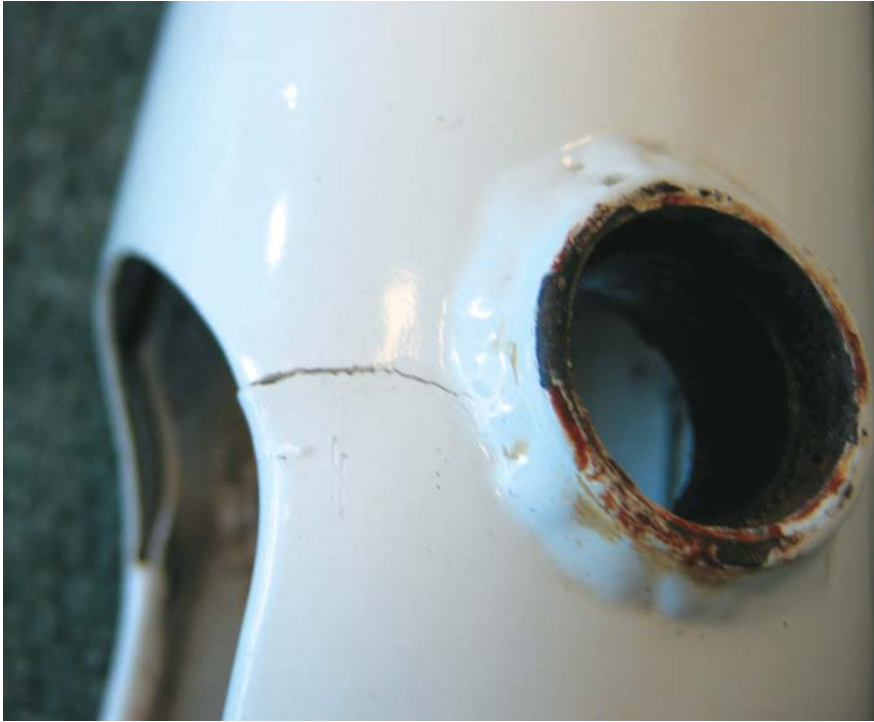
Pioneer 300 Main Undercarriage Crack

Some time ago I received a report of some fairly serious cracking on the main legs of a Pioneer 300 aircraft. This aircraft had a fair number of hours on it and had recently been taken on by a new, and no doubt very proud, owner. There were a number of issues about this particular undercarriage which were unusual, and I won't bore you with these but, when both legs end up cracking in the same place, at the same time, then fatigue needs to be considered. Later legs are of a slightly different design, and Alpi has supplied this customer with new main undercarriage legs free of charge, which says a lot about Alpi's commitment to continuing customer support. Alpi has now called for a repetitive inspection on these legs by issuing a Service Bulletin; these cracks were entirely visible and should have been spotted earlier. Unlike the Pulsar

aircraft above the Alpi Pioneer 300 was designed as a tricycle type, and don't forget that it is a retractable. I note that the later Hawk has a beefed-up nose undercarriage which increases its max all up weight a bit; this new undercarriage is retrofitable onto the older Pioneer 300's.

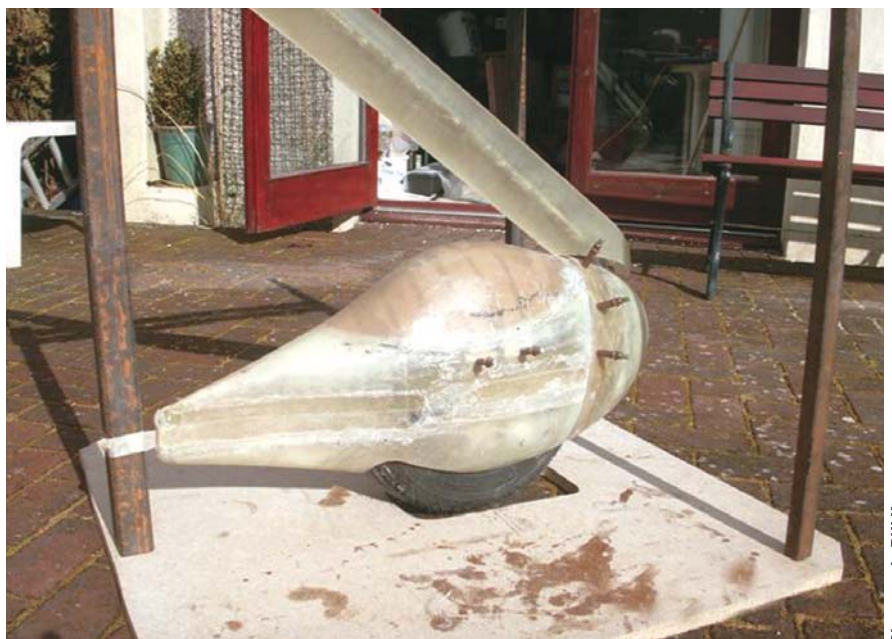
Bill Knott's 'Big Wheel Mod' under development

The LAA has been holding back on issuing an Airworthiness Information Leaflet about this as one of our members, Bill Knott, has been coming up with a mod of his own. Bill's mod uses a UK manufactured fork which he has designed to accept a big tyre (5.00 x 5), this actually increases the fork-to-ground dimension by two inches. This extra ground clearance has to be a good idea in the UK where the airfields can get a bit on the bumpy side. The Bill Knott 'big tyre' mod. has now completed flight testing and is fully approved by the LAA; if you're a Vans owner you should have received the AIL explaining your options by the time you're reading this. The only down side, as far as I see it, to Bill's mod. is that the spat will need to be increased in size to accommodate the larger wheel ... small beer, I suppose, if you've built your own aircraft; remember, Vans recommend that their aircraft should not be flown without a spat. These nosewheel mods only effect kits supplied before February 2005, more information can be found on the Vans website if you're interested.

forks to be fitted at, or before, the next annual inspection. This modification increases the distance between the fork and the runway by about an inch and, so far, there have been no 'dig-in' incidents involving modified nose forks.

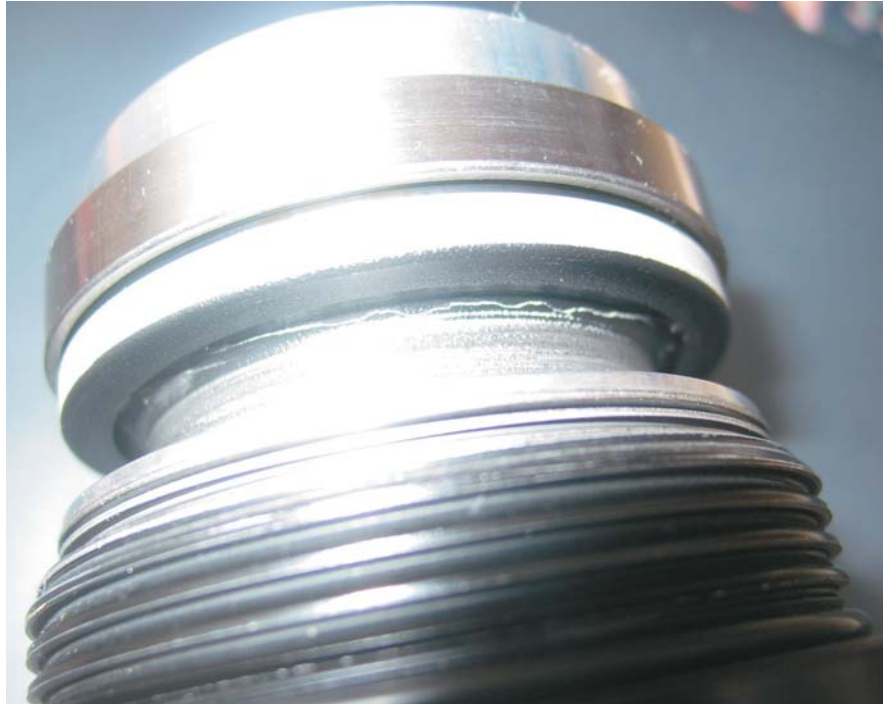
Airmaster AP332 Ferrule Crack

We have had a report of a cracked ferrule on an Airmaster 332 that has been operating with a Jabiru engine which we are a little concerned about. Airmaster propellers are mostly fitted to Europa aircraft which are generally powered by the Rotax 912/914 engines; these engines are fairly high revving four-strokes and use a gearbox to reduce propeller RPM. This gearbox has the effect of damping out, or at least limiting, peak loads from the engine to the propeller hub. We have had no reports of problems with the AP332 coupled to a Rotax and only one reported problem with the Jabiru. The Jab engine doesn't use a gearbox and so the propeller hub takes all the loads directly and runs at a generally higher RPM. Peak power on the Jab 3300 (120 Hp) is at 3300 RPM, which is the prop speed; Rotax 912 peak (80 – 100 Hp.) is 4800 RPM through

The Airmaster 332 is a fully feathering propeller that uses an electric motor to adjust the pitch of the blades in flight, Airmaster us Warp Drive carbon fibre blades and, so far at least, these blades have demonstrated a good service history. Where possible, the LAA always likes the manufacturers to issue Service Bulletins to cover in-service problems, we might back this up with an Airworthiness Information Leaflet. I am in negotiation with the Airmaster factory at this moment regarding the cracked ferrule on the Europa propeller, I know that Martin Eskildsen, the Airmaster boss, is in the process of testing the hubs on Jabiru engines. One thing that Martin

highlights is that there is already a 25 hr/50 hr/ 100 hr inspection routine and owners should be mindful that inspections called by component designers are particularly important and shouldn't be missed out.

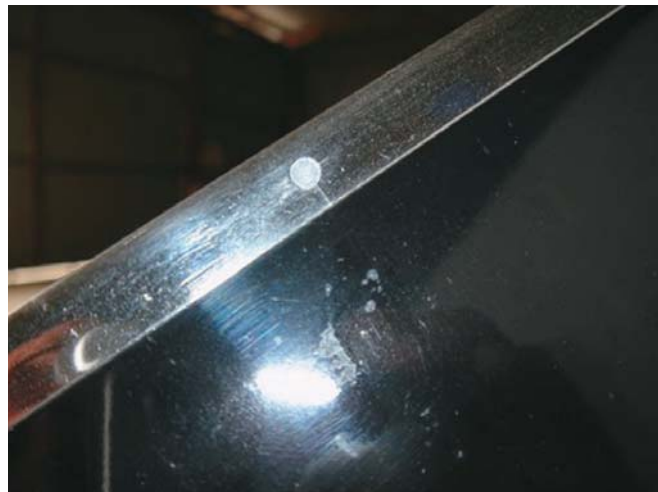
Woodcomp 'Effic' metal leading edge failure

Last, but not least, please take a look at the crack emanating from the rivet that was put in place to assist in securing a metal leading edge 'protector' on this woodcomp Effic propeller. I do not intent to harp on about this bit of design brilliance ... Suffice to say that there were two propellers with this improvement (?) operating in the UK on SportCruiser aircraft ... They aren't any more! With that gem ... *Fair Winds!* ■
