THE CASE OF THE EXPANDING HOLE

This month we close the mysterious cases of a Pioneer 300's oval wing spar bolt holes and the strange sounds in an RV4

A worrying problem found with Pioneer 300 spar plates

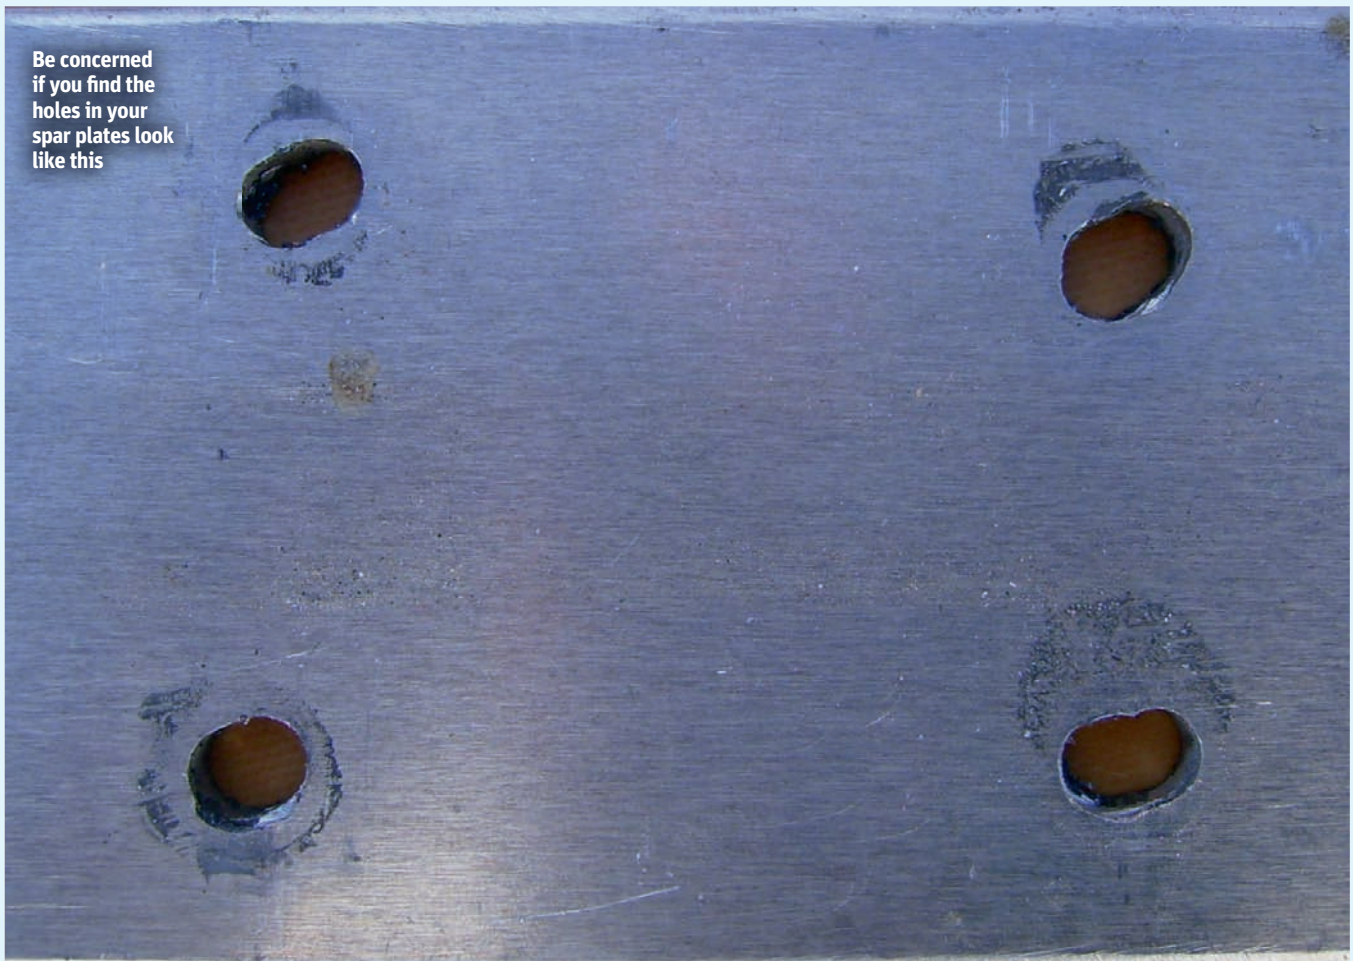
Be concerned if you find the holes in your spar plates look like this

LET me start this tale from the beginning. I received a telephone call from a very worried inspector, Simon Westley, who had removed the wings of a Pioneer 300 in order to transport the aircraft to his workshop and fix a damaged nose gear assembly. When he took the main spar bolts out he was surprised to find that the drilling was a little less than Rolls Royce quality. Concerned that this might indicate a serious safety problem with one of our most popular kits, I took a ride over to Simon's strip near Cranfield with Francis Donaldson, the Chief Engineer, to take a look.

Corrado found it difficult to see how this damage could have occurred. He explained that the holes in the spar plates were jig-drilled to very high tolerances at the Alpi factory and that the company also trial-fitted all wings and spar plates before the kits are released, so there was no reason for the holes to have been interfered with.

As it transpired, some owners have found the wings a tight fit and difficult to push fully

into place so that the factory jig-drilled bolt holes lined up. Incredibly, some have solved the problem by pushing a drill through the bolt holes to 'stretch' the holes rather than devising a means to pull the wings that last smidgen into the proper place.

This is an absolute no-no with critical aircraft structures. Bolt holes must be round, the right size and free from stress-raising burrs. Bodging a hole means that bolts in a group will not carry the load evenly, some may carry more than their fair share of the load causing them to break, subsequently overloading the remaining bolts, which in turn will also inevitably fail if the situation is not dealt with. This is what's called a 'zip-fastener' type failure. Alternatively cracks may start to manifest in the plate under tension due to the stress concentrations caused by the burred holes. These will grow quietly in length

until one day the plate will fall in half and the wings separate from the fuselage.

This allows us to issue a mandatory bulletin in a matter of days rather than waiting to discuss the matter at one of our monthly Airworthiness Review Meetings when all the Engineering staff chew over a batch of airworthiness issues at length. A bulletin was sent out to all owners straight away requiring urgent inspections of the wing spar plates and replacement of any that had been mis-drilled. As a result, several more cases came to light. Luckily, replacing the plates is not too difficult or expensive a job.

If you ever find yourself poised with drill in hand, about to match up two holes that don't line up, STOP! Put the drill down, step away from your aircraft, have a cup of coffee, figure out why the holes aren't lining up (especially if they did before) and consider how you should cure the disease rather than just treat the symptom. Bolt holes must be round, not oval. Never rely on the bolt clamping up an airframe joint, it's the shank in the hole that does the job.
