<b>Standard Modification</b> Issue 1	Mod No. SM11906
		Page : 1 of 9
		Compiled : P Tunney
		Approved : F Donaldson

## TITLE : Tailplane Torque Tube Clamps

**APPLICABILITY : All Europa Variants**  
**Mod Type : New build & Retro-fit**

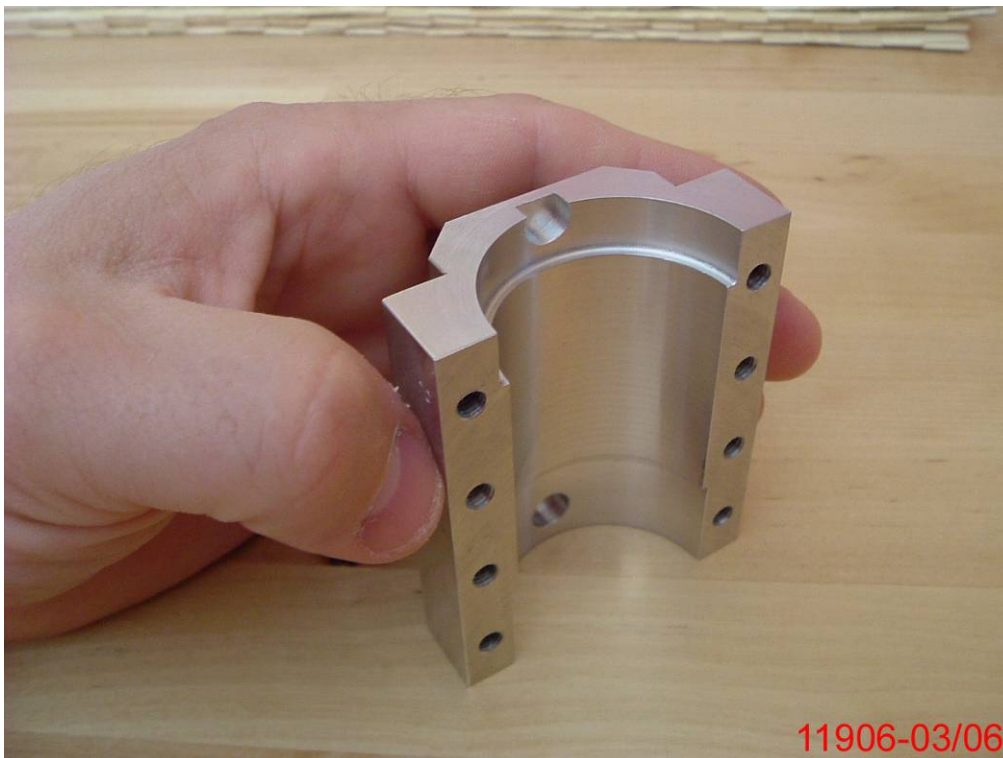
Drawing No.	Title / Description	Issue
11906-01/06	Existing torque tube design and detail	First
11906-02/06	Dimensional drawing of clamp / nylon sleeve / dowel pins and cap head bolts	Rev G
11906-03/06	Clamp half image	n/a
11906-04/06	Clamp half image	n/a
11906-05/06	Clamp half image	n/a
11906-06/06	Half clamp installed looking aft	n/a
11906-07/06	Torque tube showing new short dowels	n/a
11906-08/06	Clamps installed looking towards port side	n/a
11906-09/06	Clamps installed looking towards starboard side	n/a
11906-10/06	Clamps installed looking aft	n/a

**3.02** The clamps are machined to actual diameters and spacing measurements of the owners individual torque tube. This is a requirement as the torque tube components supplied by Europa Aircraft vary in size depending on the drawing issue. Sizes as specified on the drawing 11906-02/06 must be obtained prior to final machining of the clamps. The finished bore sizes of the clamps must be 0.002" (0.05mm) smaller than the diameters they will locate on to.
