## Mystery of the Tippy sunglasses

# Spark plug failure

# Investigating on-going power loss

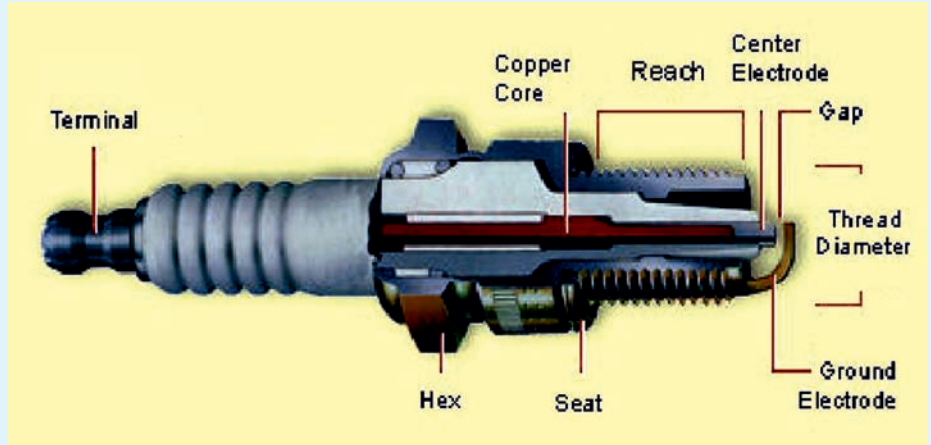
**The construction of a typical automotive sparking plug, which has remained unchanged for many years and is usually ultra reliable. Was it just a case of Neil's coming from a rogue batch?**
