LAA AWA/12/03
28th March 2012

Dragon Wings Rotors

Inspection of Hub Bar

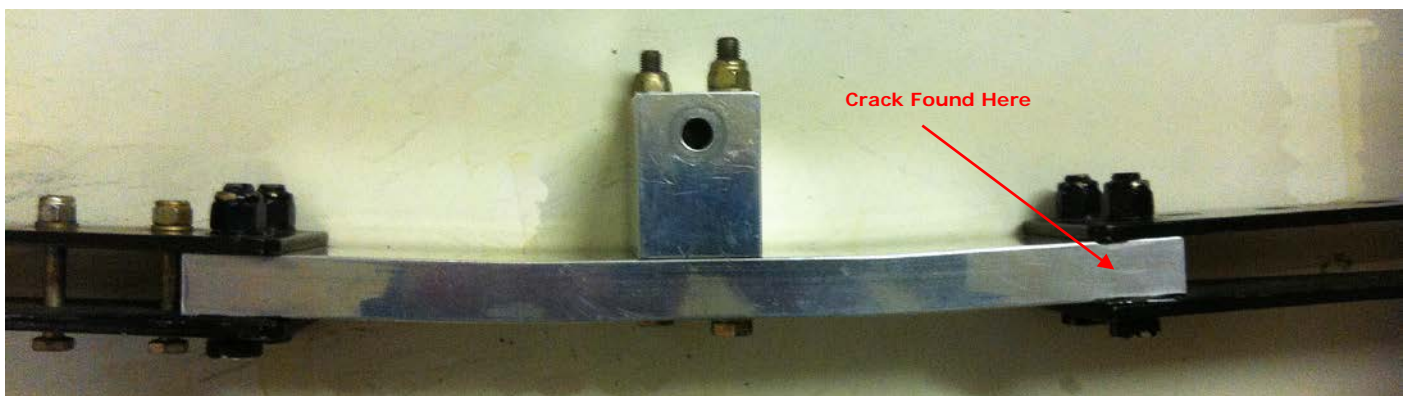
Fig. 2. Hub Bar Assembly minus Blades

During a pre-flight inspection of a Montgomery-Bensen B8 Autogyro the inspecting pilot notice a hairline crack in the outside face of the Hub Bar.

During the investigation into this event a number of possible causes for this crack were suggested including, blade flap, over-tightening of the attachment bolt(s), incorrect tolerances during blade assembly, fatigue or incorrect assembly /disassembly methods of the blades from the rotor.

Unfortunately, it was not possible to obtain the cracked Hub Bar for inspection and so the actual cause of this crack will remain a mystery. After discussions with the manufacturer of this Hub Bar and LAA Inspectors with substantial experience with this rotor assembly, it was agreed that the most probable cause of the event was that, at some time in this Hub Bar's history, an incorrect assembly/disassembly procedure was used.

After discussion with the UK CAA the LAA has issued an Airworthiness Information Leaflet (AIL) requiring pilots of aircraft fitted with Dragon Wings Rotors to visually inspect the rotor head before each flight (LAA/MOD/GYRO/001 issue 1). In addition to this, the AIL requires a close inspection of the Hub Bar at each annual inspection; this annual inspection requires the removal of the blades from the Hub Bar.
