LAA/AWA/19/22  
27<sup>th</sup> November 2019

## Jodel DR100 (Series) Aircraft Inspection of the Tubular Frame of the Front Seats

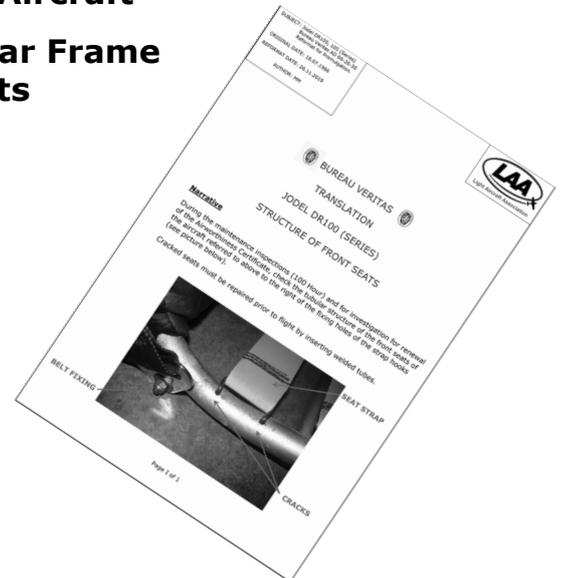
Fig 1. In the 1960s the French authorities employed Bureau Veritas (BV) to oversee certification and continuing airworthiness matters; that's why many of the early Airworthiness Directives issued for French aircraft of that period bear the BV Logo. Because of this recent seat failure event involving a Jodel, the LAA has reformatted the relevant BV AD and have widened the required inspection area by issuing an Airworthiness Information Leaflet
