LAA/AWA/19/20(2)
28th October 2019

Auster 6A (Series) and Beagle Terrier (Series)

Inspection of Flap Auto-Trim Interconnect Cables

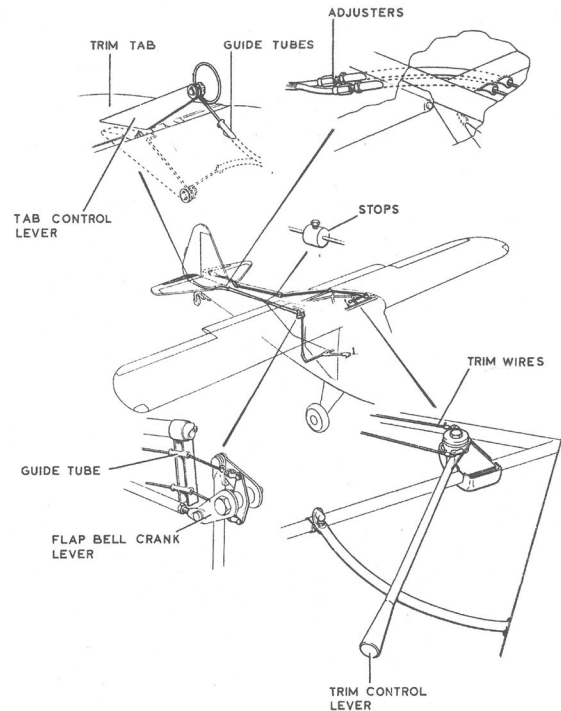
Fig 1. This sketch, extracted from the Beagle Terrier maintenance manual, shows the key elements in the two longitudinal trim systems fitted to Auster types.

Because of this recent incident, LAA Engineering has issued an Airworthiness Information Leaflet (AIL) requiring operators of Auster and Beagle Terrier aircraft to inspect the flap-trim interconnect cables each 100 hrs. or every three years coincident with the Permit renewal inspection.
