LAA/AWA/18/05
25th July 2018

Sensenich 2 Bladed Ground Adjustable Propeller

Inspection of Propeller Hub

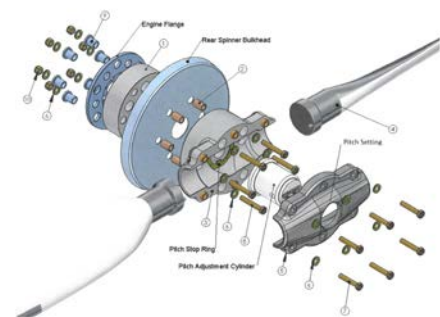
Fig 1. This sketch shows the general arrangement of parts that make up the Sensenich ground adjustable propeller assembly as fitted to a Rotax engine; but note, actual installation instructions differ between engine and airframe types.

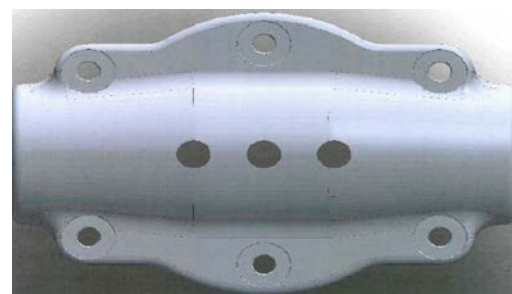
Fig 3. This picture shows the front half of a later model 2A0 propeller hub (Revision 'E' and later). This model hub (and the three blade equivalent) are not affected by SB2016-06B
