LAA TYPE ACCEPTANCE DATA SHEET
TADS 301
DYN AERO MCR-01 VLA

This TADS is intended as a summary of available information about the type and should be used during the build, operation and permit revalidation phases to help owners and inspectors. Although it is hoped that this document is as complete as possible, other sources may contain more up to date information, e.g. the manufacturer's website.

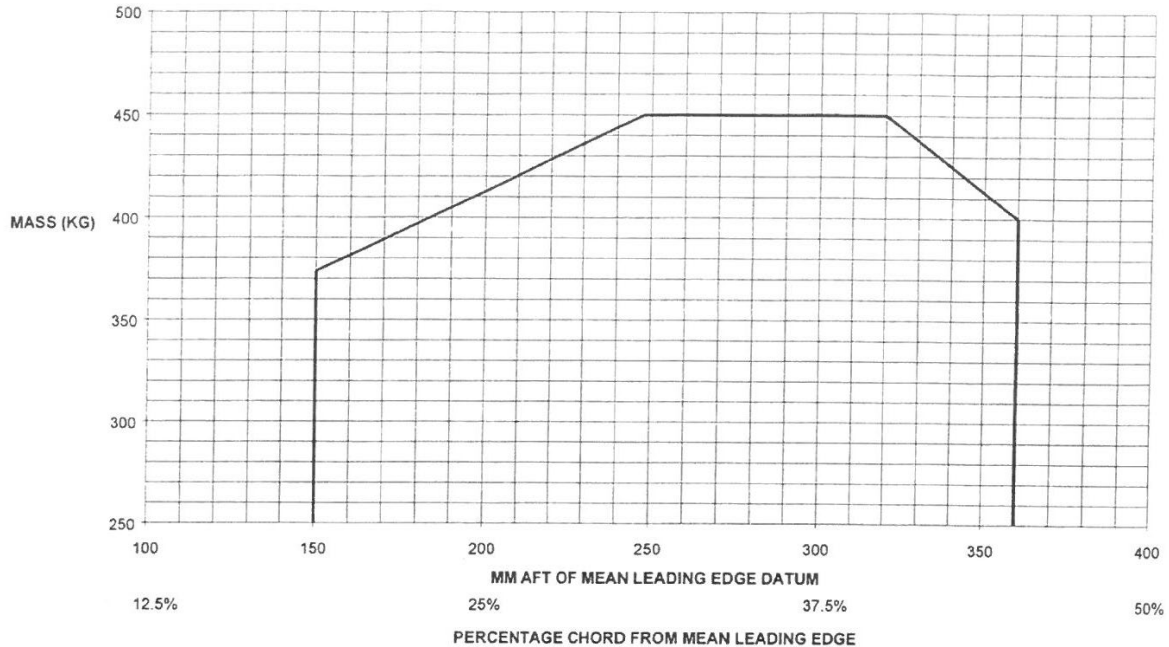
Figure 1. Weight and Balance Envelope

DYN-AERO MCR-01 WEIGHT AND BALANCE ENVELOPE

Datum Point is: Mean leading edge of port and starboard wing (which is a point 13.5 mm forward of the left wing leading edge at root).
