LAA/AWA/18/07  
31<sup>st</sup> July 2018

## Non-EASA (GA) Aircraft Safety Harness Integrity

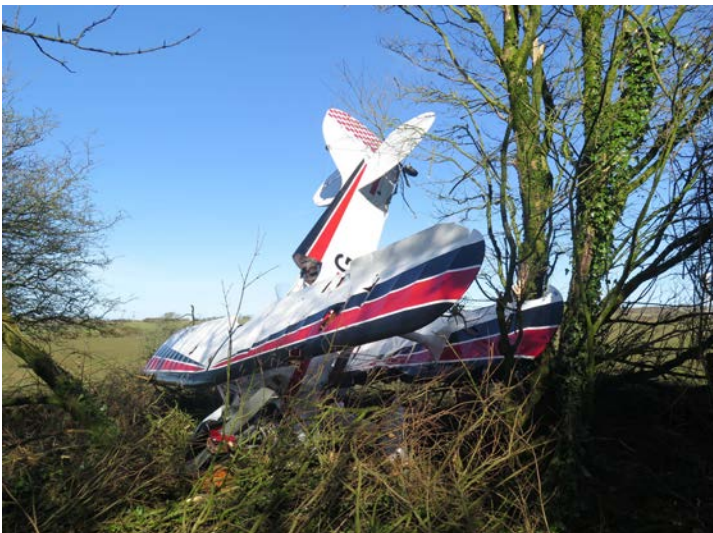
Fig 1. The Pilot of this Steen Skybolt recently suffered a catastrophic mechanical failure of his engine; the aircraft entered a spin and was brought to rest by a copse of trees. The pilot suffered only minor injuries and was able to walk clear of the aircraft because of a good deal of luck (a well-placed spinney) and a full harness that was in perfect condition.

LAA Engineering consider the general advice provided in the CAA Safety Notice to be sound and recommend that owners monitor the condition of the safety harness in their aircraft and ensure that it remains in good condition. SN-2018/005 can be downloaded [HERE](#).

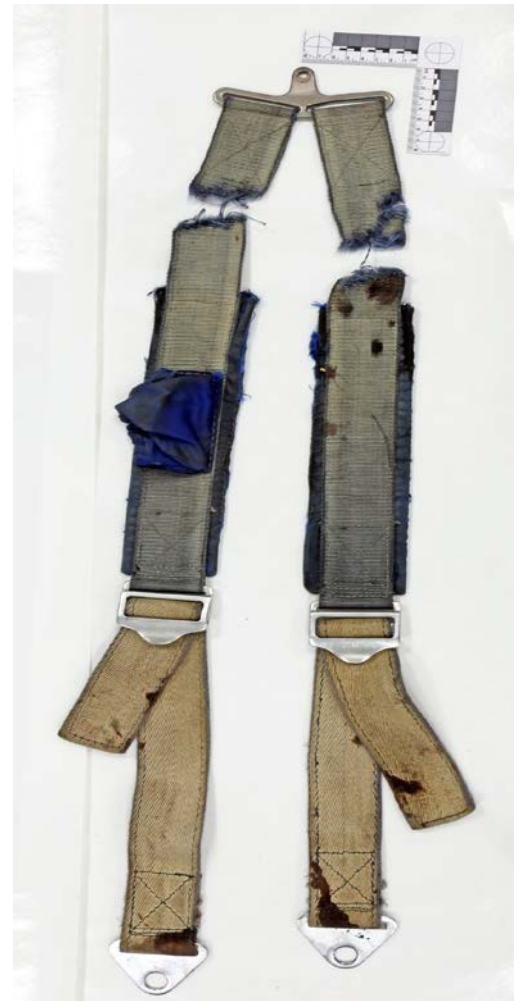
In response to a recommendation from the Air Accident Investigation Branch (AAIB) following a fatal accident involving a YAK-52 aircraft in July 2016, the UK Civil Aviation Authority (CAA) has published a Safety Notice (SN-2018/005) emphasising the importance of ensuring that safety harnesses are in good condition.

Fig 2. One pilot died and the other was seriously injured during an unsuccessful forced landing after an engine stoppage in a YAK-52 aircraft. The picture above shows the failed rear seat shoulder harness – when tested it was found that the harness had degraded such that its strength had reduced by up to 50%.
