<b>Standard Modification</b> Issue 1	Mod No. SM12349
		Page : 1 of 3
		Compiled : G McDill
		Approved : F Donaldson

## TITLE : Static Longitudinal Stability Augmentation

APPLICABILITY : **Rans S-7S**  
Mod Type : **New build and Retro-fit**

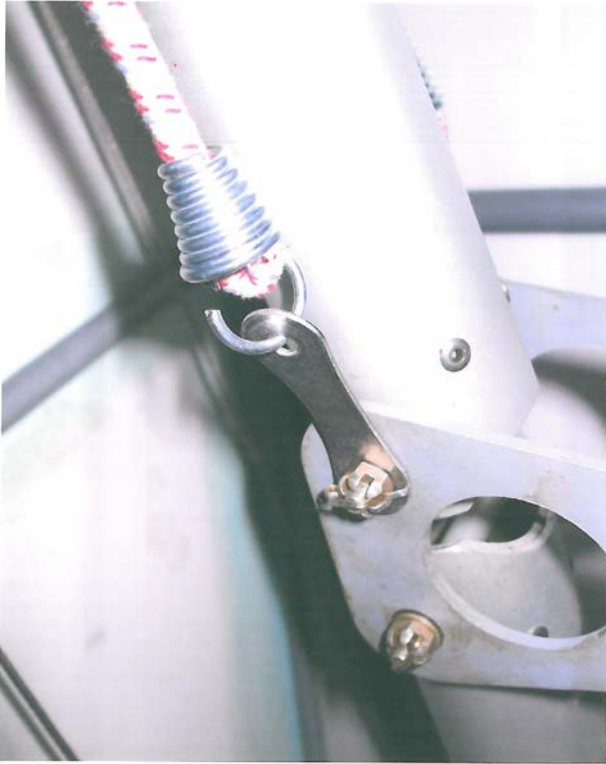
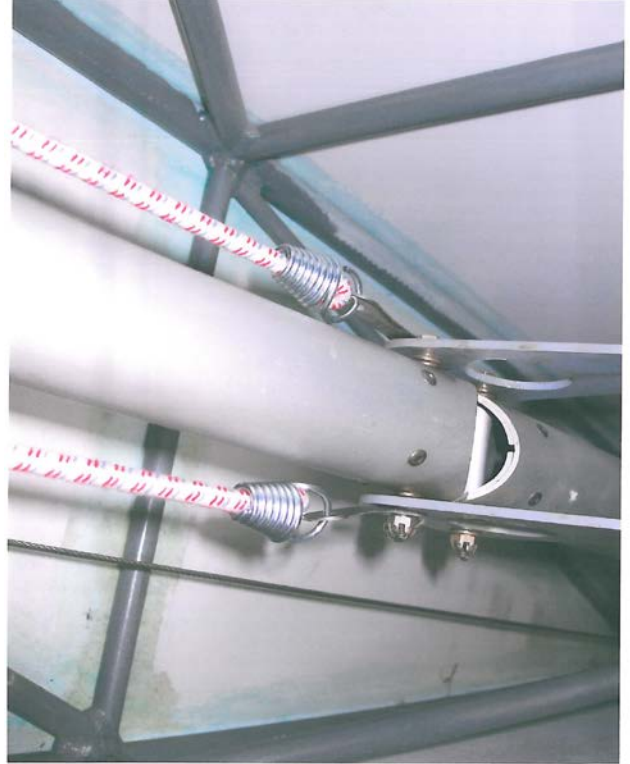
Photo **1**

Photo No.	Title / Description	Issue
1 and 1a	Bungee attachment at idler bellcrank at St6	1
2	Bungee attachment at St3 welded hoop	1
3	Alternative arrangement for bungee attachment at St3 frame	1

Attach the bungees to the Hummertangs installed at the forward AN3-25 bolt on the elevator push-pull tube/idler bellcrank in the rear fuselage at St6. See photos 1 and 1a. It will be necessary to adjust the washer arrangement to ensure free movement of the Hummertangs and retain the ability to split-pin the castellated nut. It may also be necessary to replace the AN3-25 bolt with an AN3-26 if adequate clearance cannot be achieved.
